Technical Report M 68

**UPPER BROWN'S BAR HSR MODEL
MISSISSIPPI RIVER MILES 29.00 – 20.00
HYDRAULIC SEDIMENT RESPONSE MODEL INVESTIGATION**

U.S. ARMY CORPS OF ENGINEERS
ST. LOUIS DISTRICT
HYDROLOGIC AND HYDRAULICS BRANCH
APPLIED RIVER ENGINEERING CENTER
FOOT OF ARSENAL STREET
ST. LOUIS, MISSOURI 63118

Final Report – July, 2014

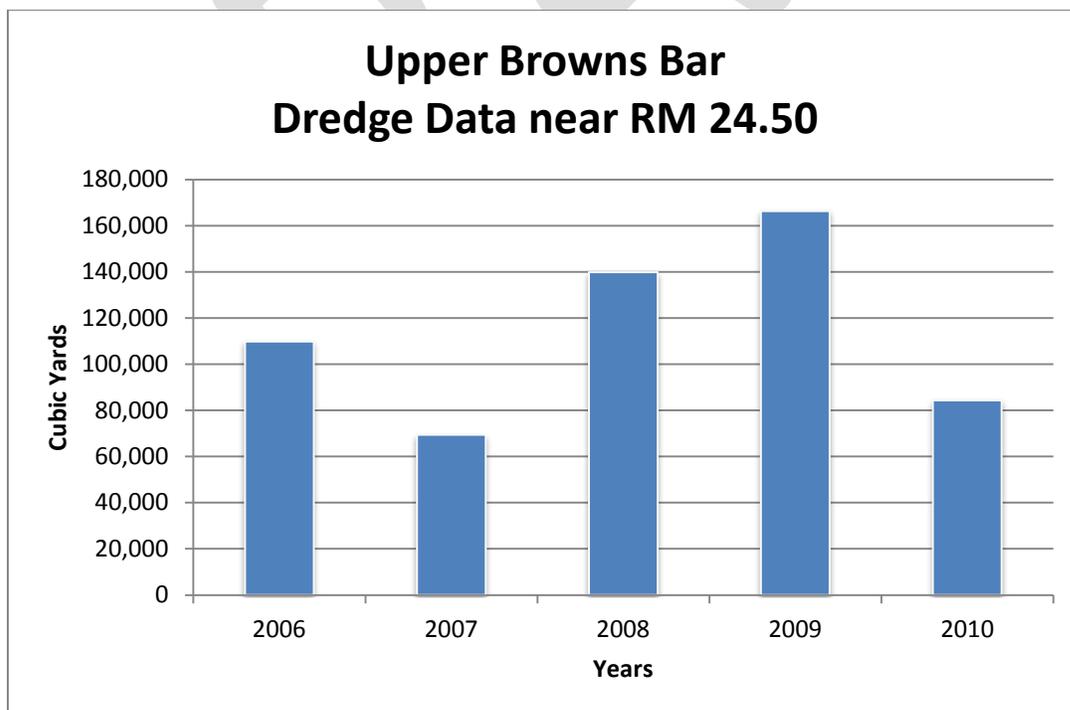
Dredging has occurred nearly every year between RM 25.00 and RM 23.75 (See Plate 2). During that time frame an average of 114,000 cubic yards was dredged near RM 24.50 at a cost of \$275,000. See Figure 1 below for dredge material removed near RM 24.50.

Figure 1: Dredge Data near RM 24.50

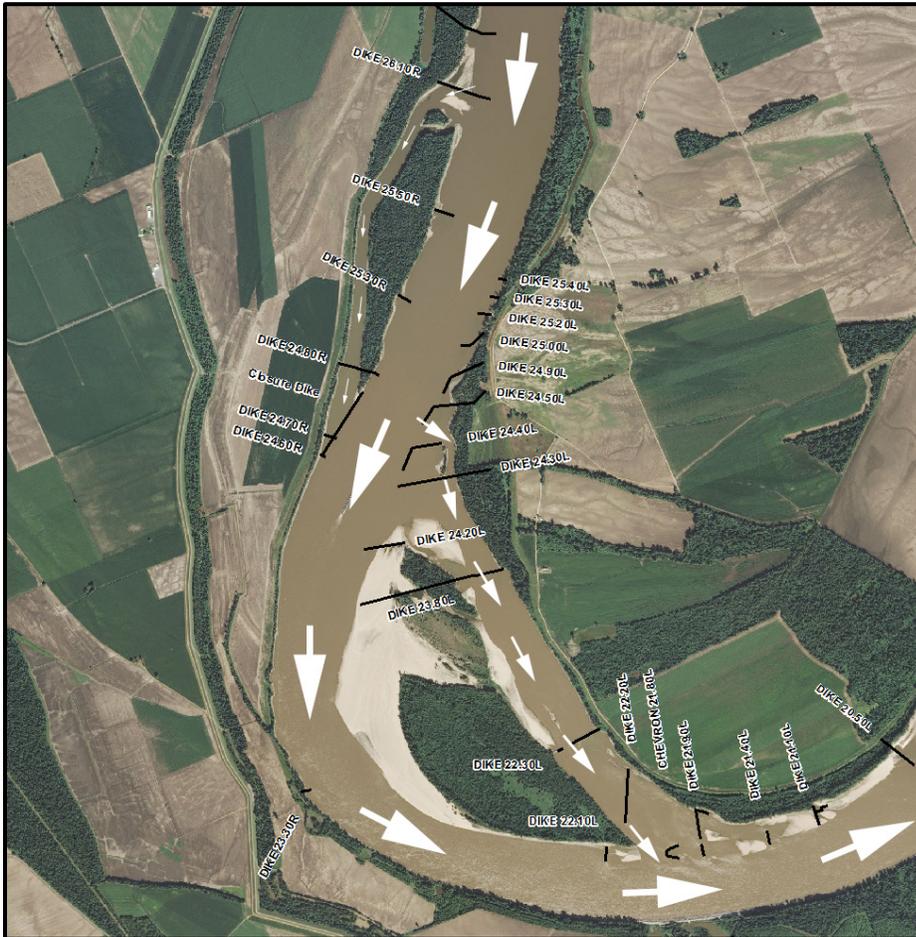
The Upper Browns Bar reach has a sharp 180 degree bend with shallow crossings in the channel, scour on the outside of the bend, and two shallow side channels. The main channel depths range from -10 feet to -50 feet LWRP. There are two closure structures in Brown's Chute with significant scour holes located just downstream. Figure 2 is a generalized schematic of the existing flow mechanics in the study reach.

Figure 2: Existing Flow Mechanics

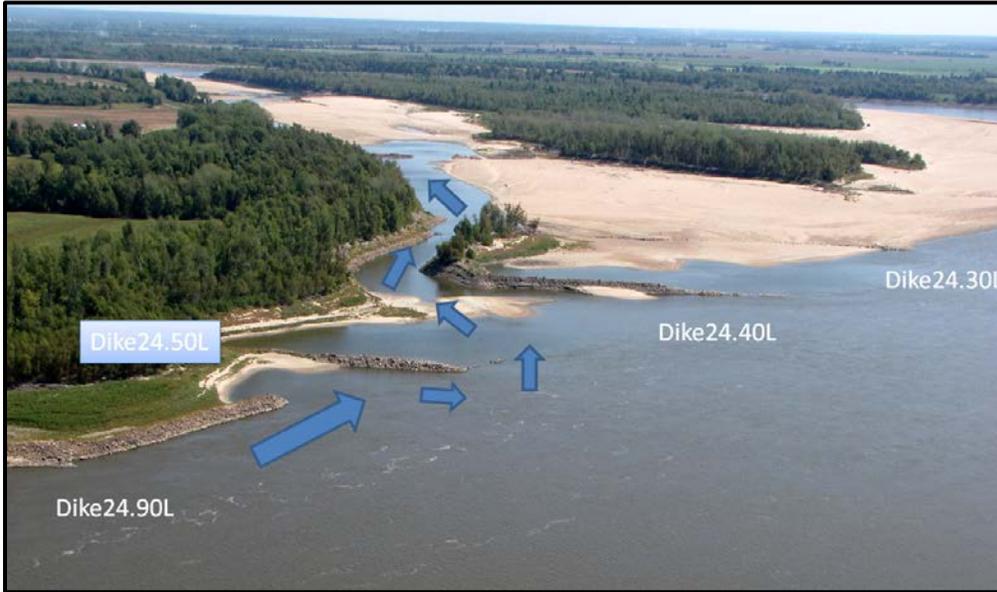
Figure 3: Looking Downstream at Upper Browns Chute (Side Channel Flow Patterns)

Based on aerial photography and flow data analysis at Upper Brown's Bar, it was determined that Dike 24.50L was the controlling structure that diverts and maintains flow to the side channel. See Figure 3 for more details. Therefore, Dike 24.50L should not be modified, along with four other dikes upstream (Dike 25.00L, 25.20L, 25.30L, and 25.40L) because they may disrupt flow in this area. Figure 4 shows the area to avoid

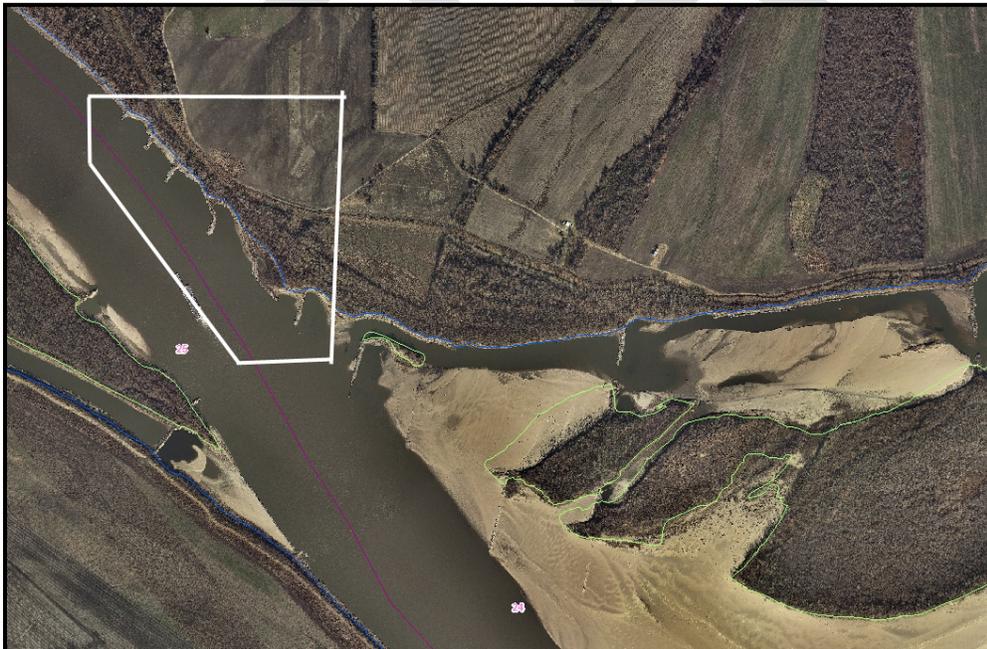
when making structural changes in order to maintain the current side channel conditions.

Figure 4: Area to avoid in order to maintaining current side channel conditions (2012 Aerial Photograph)

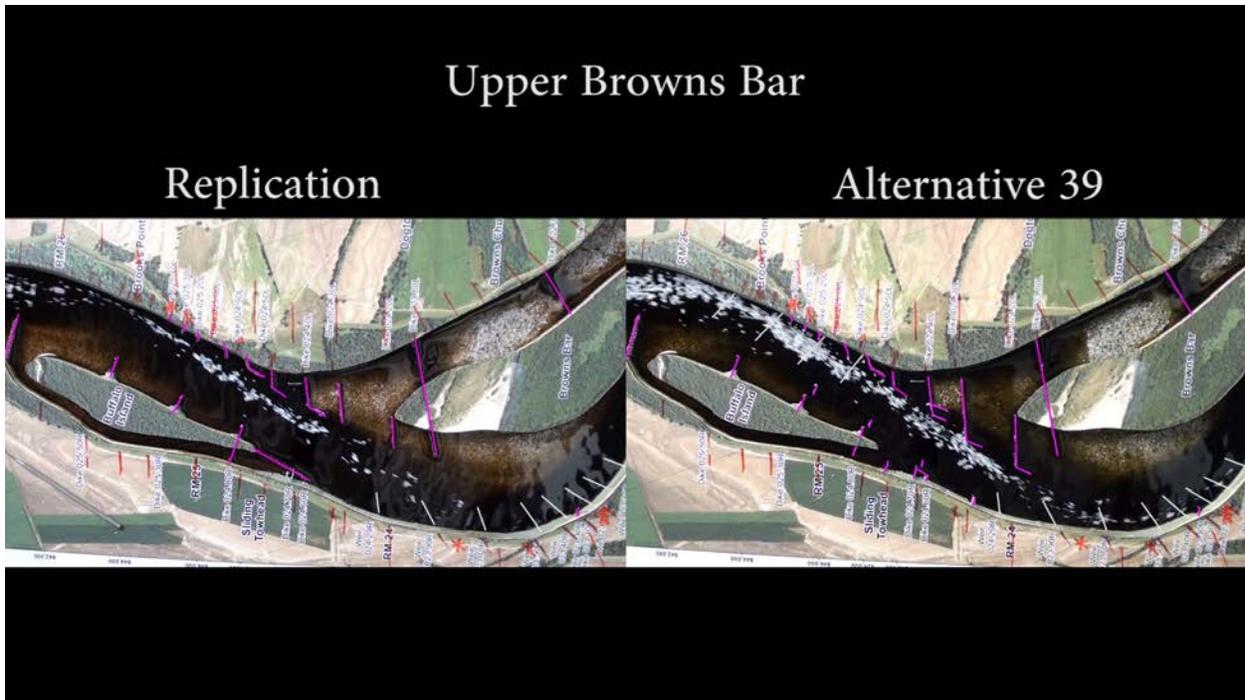
The first condition recorded was the replication test, or existing conditions as seen in Figure 5. The flow crossed over to the LDB at RM 26.0. As seen in the snapshot of the existing conditions, the resultant flow was concentrated along the LDB. Immediately downstream the flow began to disperse across the channel (sediment deposition occurred) and crossed over to the RDB at RM 24.0. No sediment movement was observed in Buffalo and Upper Browns Chutes. All structures are highlighted in pink for increased visibility.

Figure 5: Replication vs. Alternative 37 Flow Visualization

The next condition recorded was the post construction condition with the recommended alternative in place. Alternative 37 (recommended alternative) included dikes, weirs, rootless dike, L-dike extensions, and dike notching and removal that would eliminate dredging in addition to enhancing environmental diversity at Buffalo Island.

Again, the flow crossed over to the LDB at RM 26.0. As seen in the snapshot of the post construction conditions, the flow was more concentrated toward the middle of the channel. As a result, a more dependable and deeper channel was developed for industry use. When compared to the existing conditions, there was an increase in energy and sediment transport at the crossing where sediment deposition had occurred in the replication test.

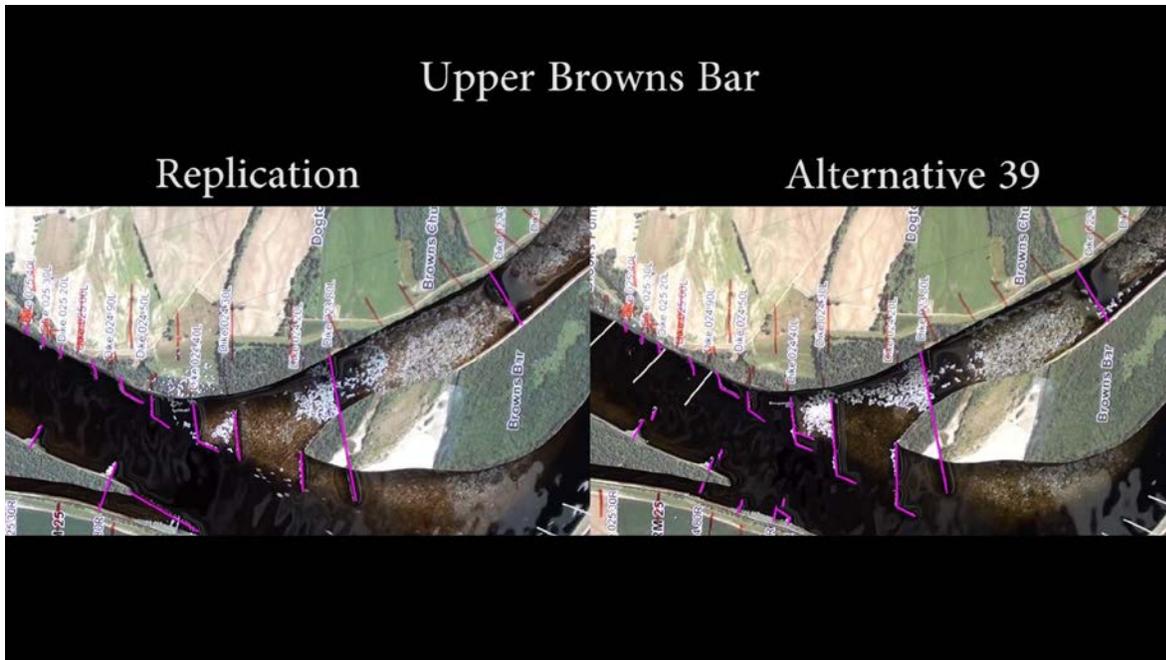
Figure 6 showed Upper Brown's Chute during replication and after construction. As seen in the snapshot, the side channel experienced similar flow patterns. No significant trends were observed.

Figure 6: Alternative 37 Upper Browns Bar Flow Visualization

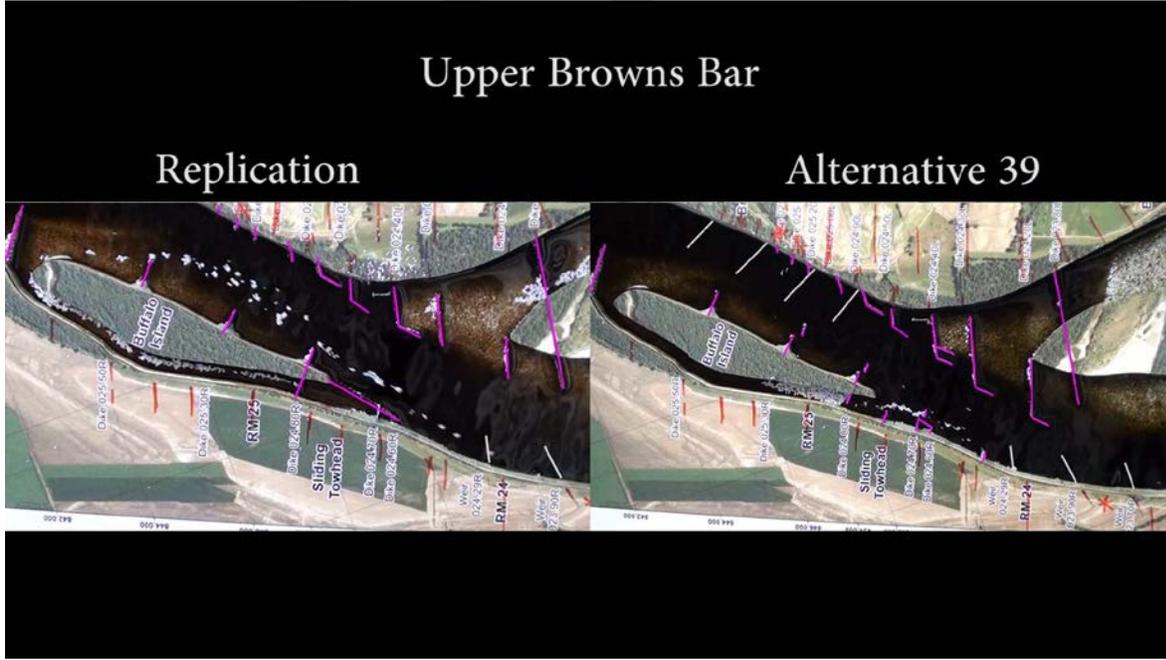
Figure 7 showed Buffalo Chute after construction. As seen in the snapshot, more flow was able to pass through the chute where the notch was located. No bed changes were observed in Buffalo Chute.

Figure 7: Alternative 37 Buffalo Island Flow Visualization
