Summary Report
Lock and Dam 24 Physical Model, Upstream Scour

By: Timothy J. Lauth
Hydraulic Design Section
US Army Corps of Engineers St. Louis District
1222 Spruce St.
St. Louis, MO 63103-2833

Executive Summary

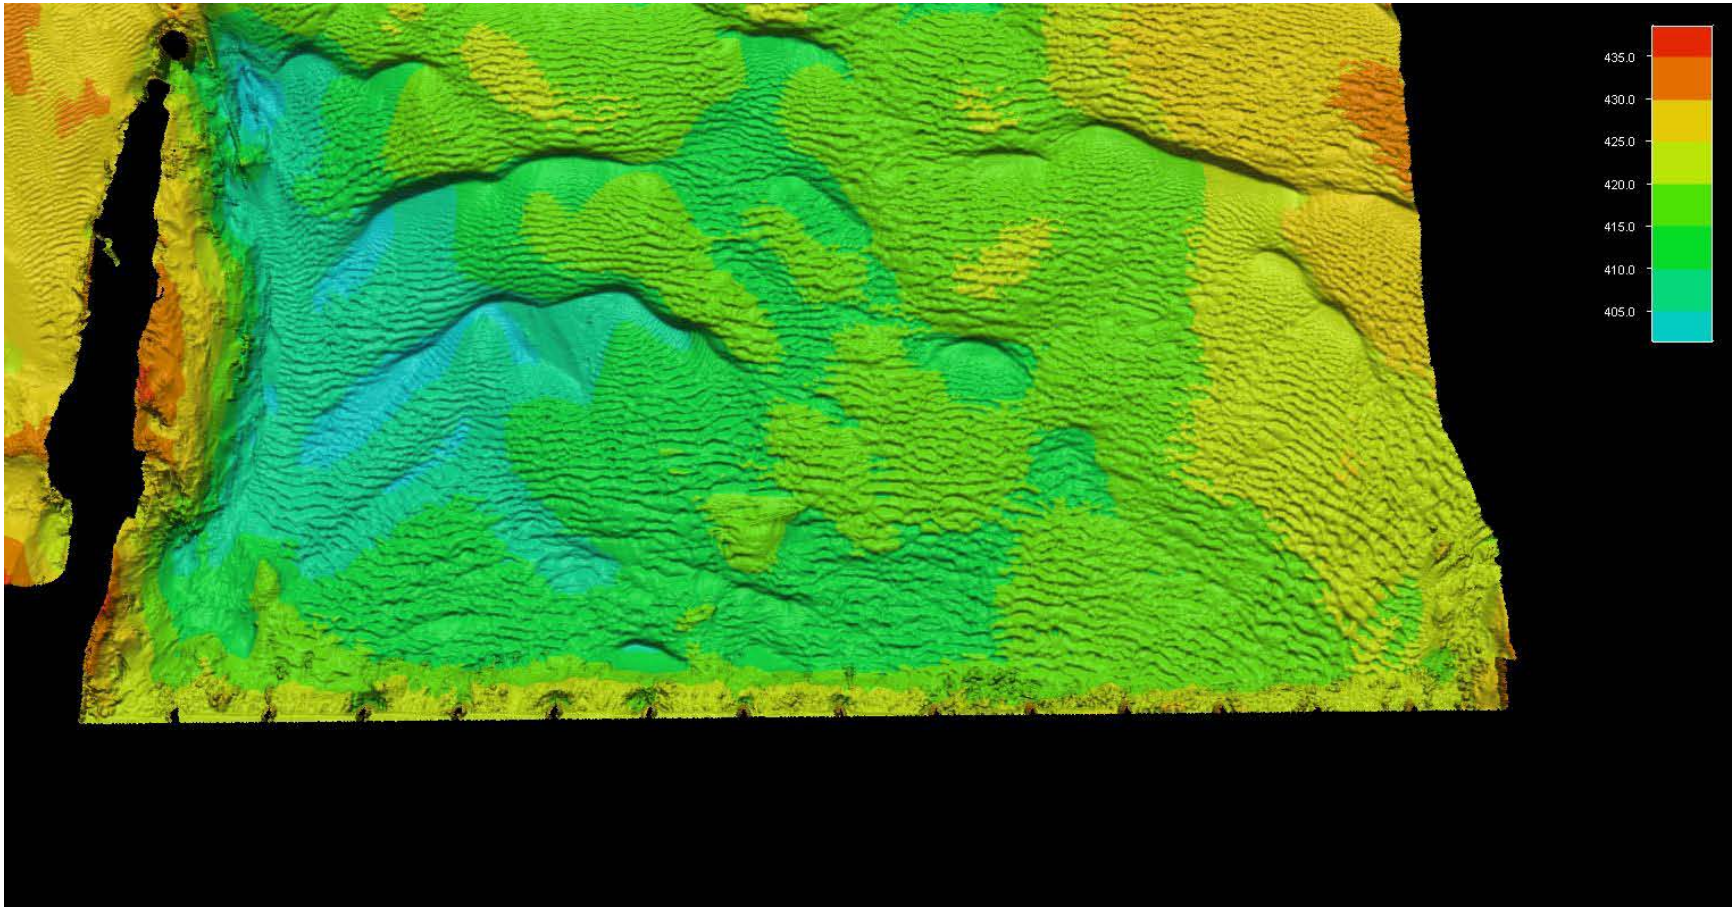
Figure 2 - 7-9-2008 Survey

2. July 9, 2008 – In the 7 months since the last survey, 1-2 ft of material were deposited in large areas upstream of the lock and dam. Further upstream, deeper deposition occurred upstream of gates 1 and 3 thru 12; scour occurred upstream of gates 13 and 14.

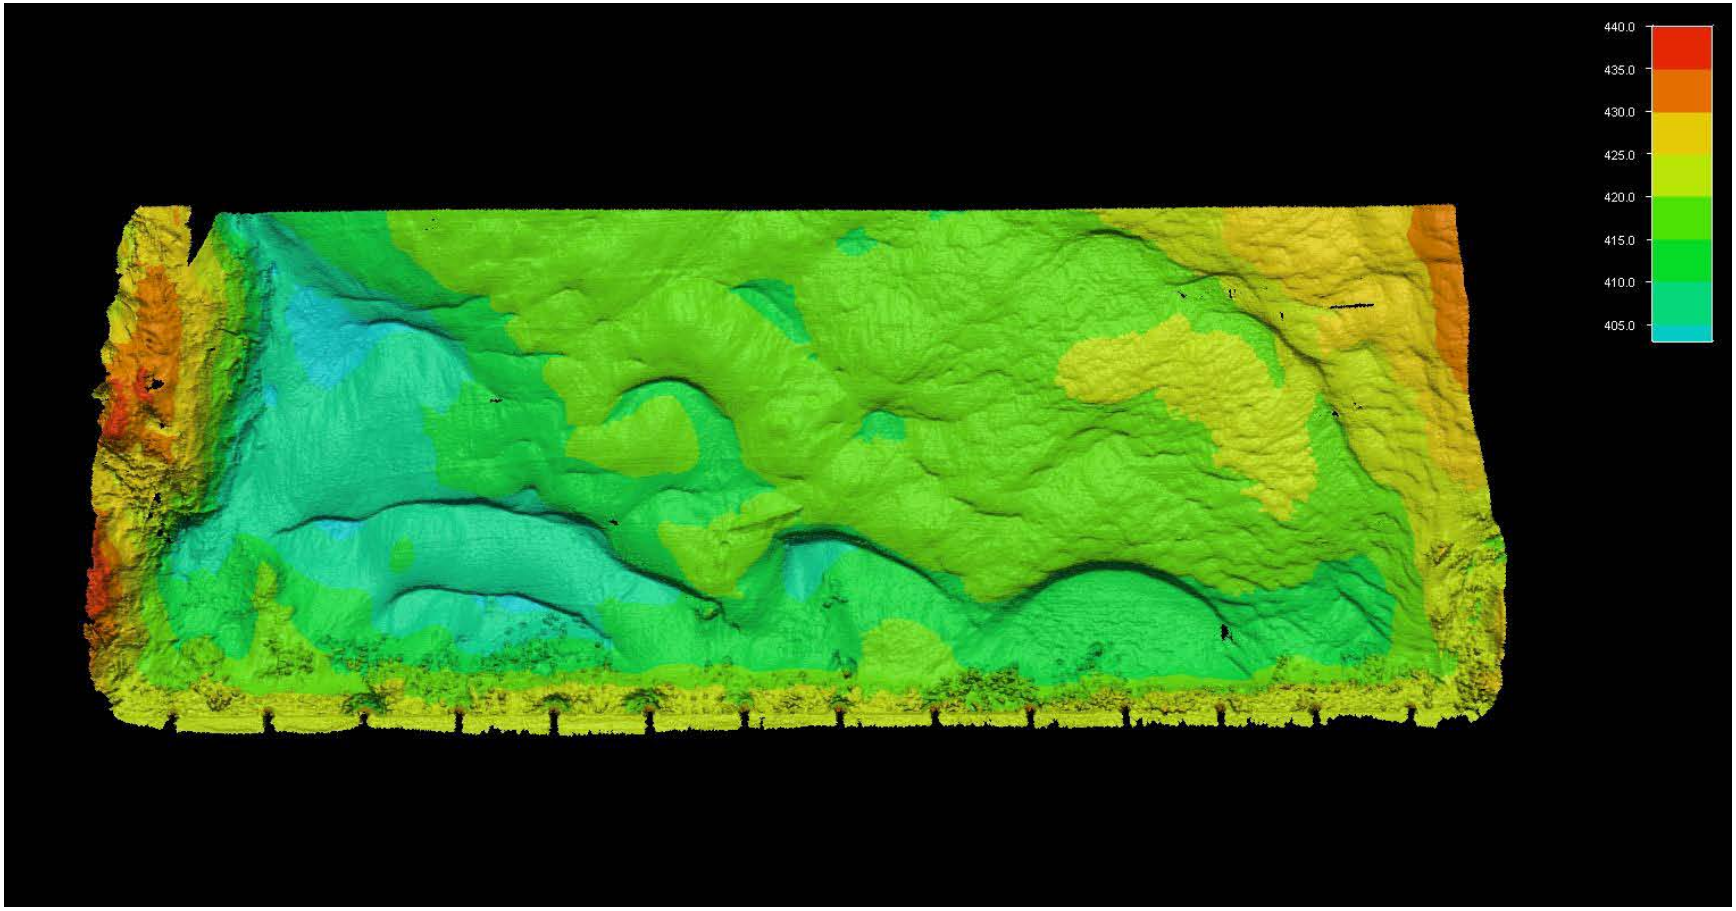
Figure 3 - 12-8-2008 Survey

3. December 8, 2008 – Five months later, the majority of the stone bed protection had changed ± 1 ft; what change outside of that occurred was a loss of material of -1 to -2 ft. Immediately upstream of the stone bed protection, losses of elevation up to -9 ft had occurred in multiple locations, though this was likely due to the passing of sand waves.

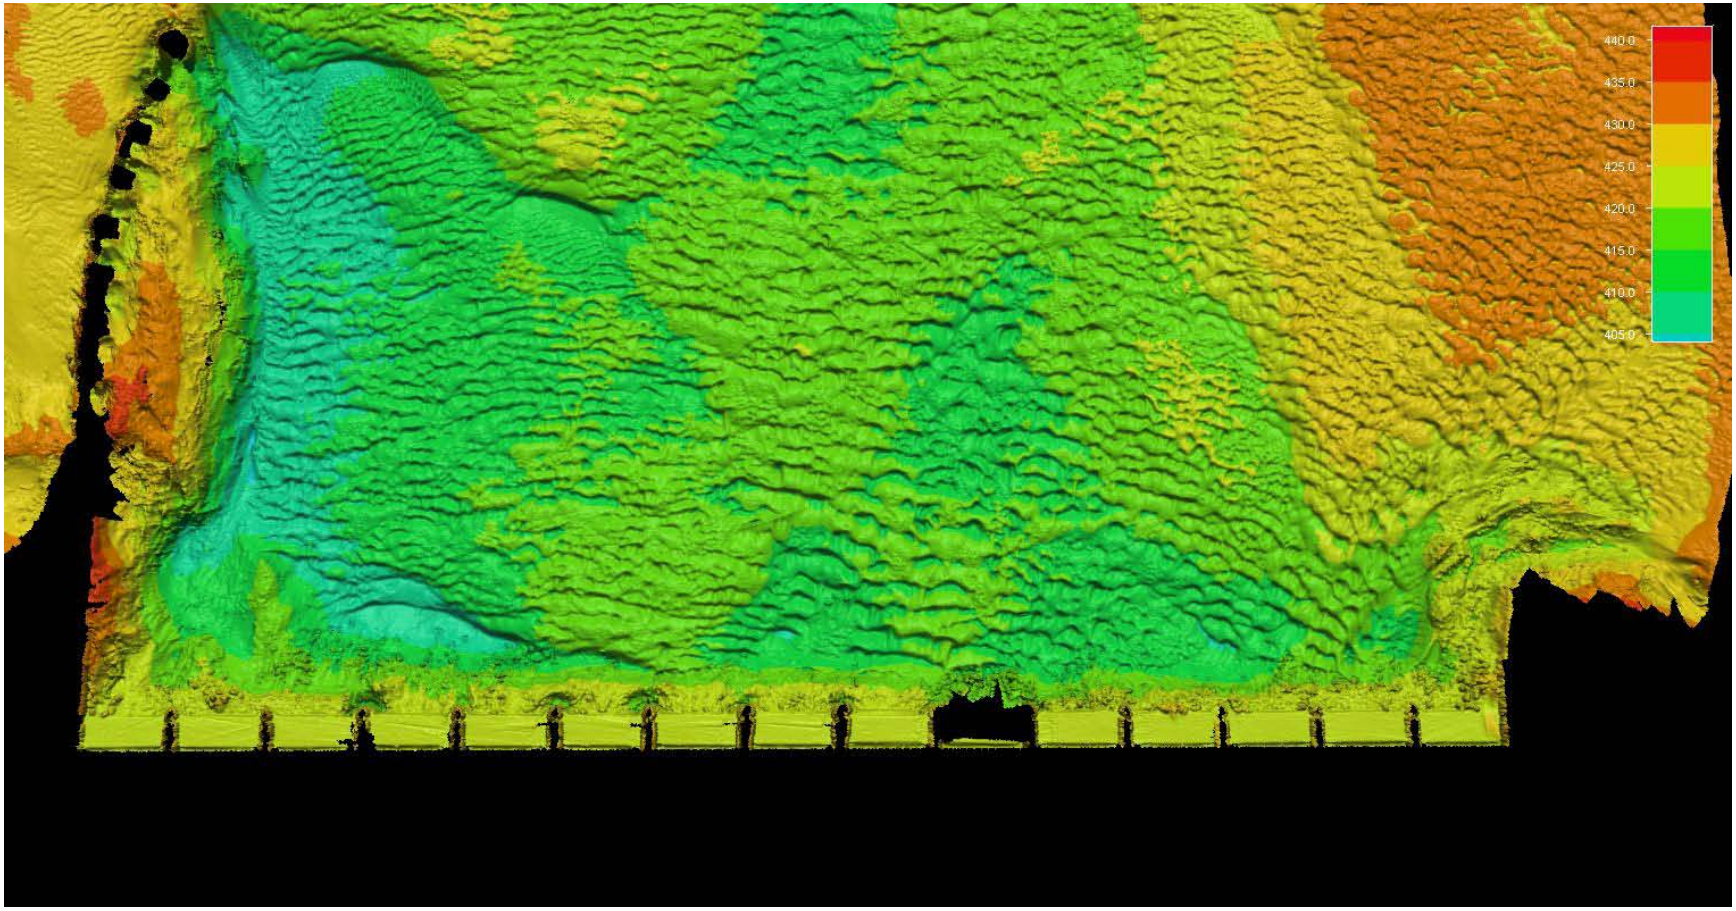
Figure 4 - 4-1-2009 Survey

4. April 1, 2009 – The first survey of the location performed in 2009 revealed little change in the stone bed protection in the preceding 4 months, and the change that did occur was typically +1 to +2 ft of aggregation. Upstream of the stone bed protection, the losses of elevation previously were once again gaining material, with gains of approximately +10 ft occurring in front of Gates 2 and 3.

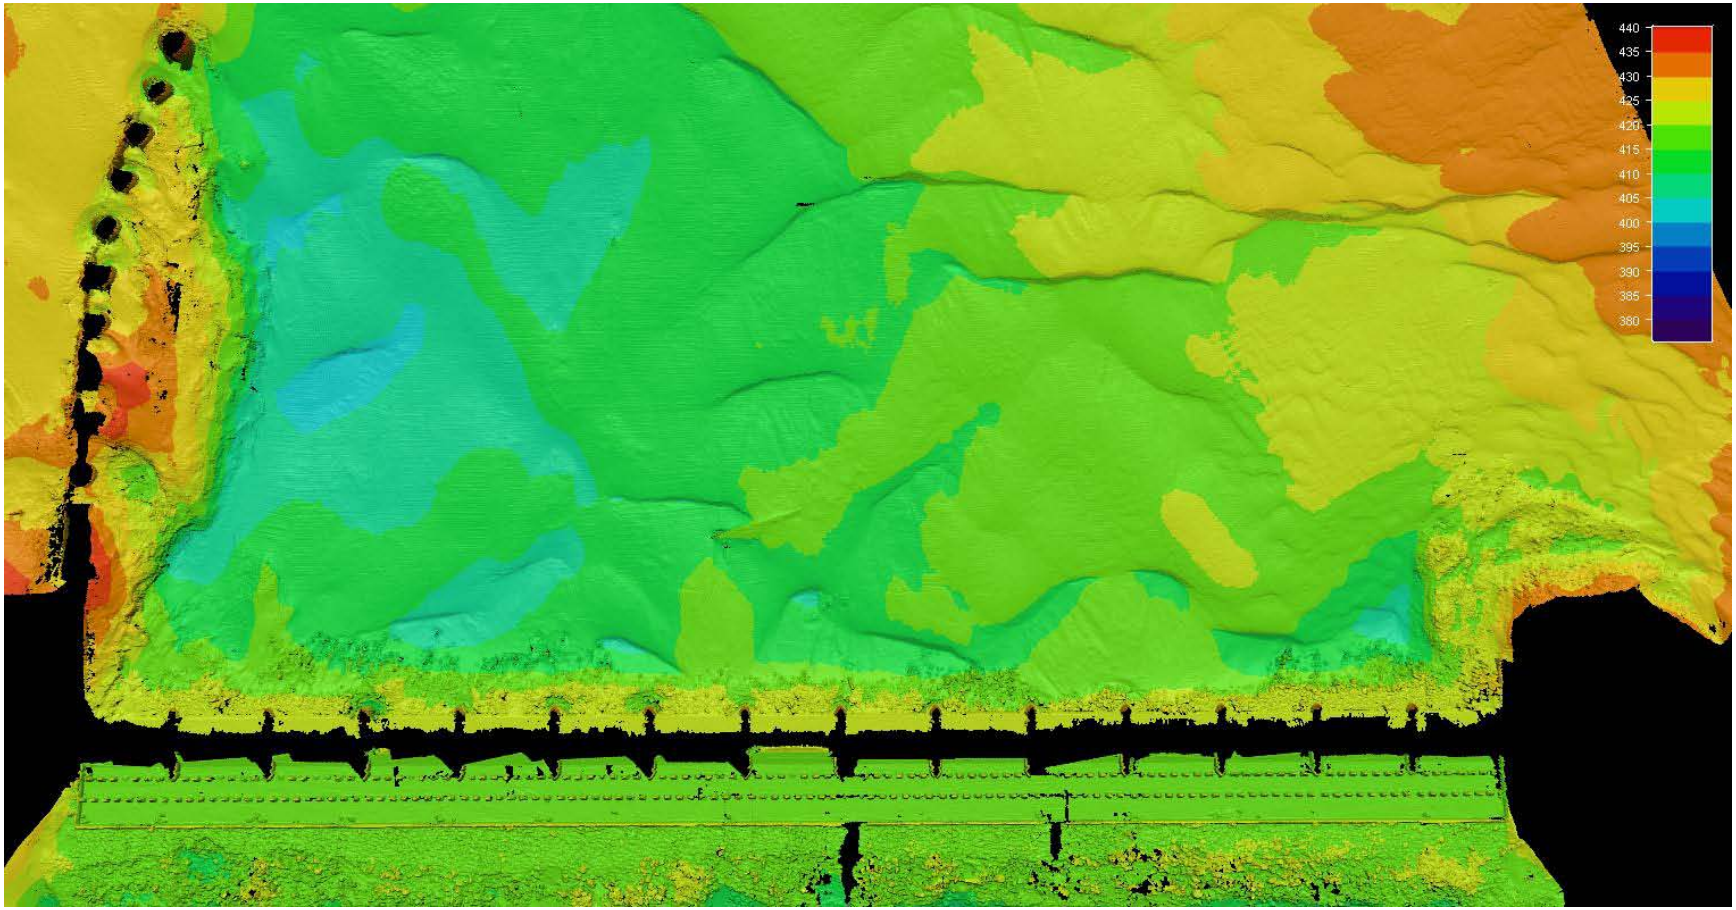
Figure 6 - 9-8-11 Survey

6. September 8, 2011 – In the 16 months since the previous survey, the stone bed protection exhibited little to no change; what change did occur was largely a loss of material of -1 to -2 ft. Changes upstream of the stone bed protection are split between deposition and erosion.

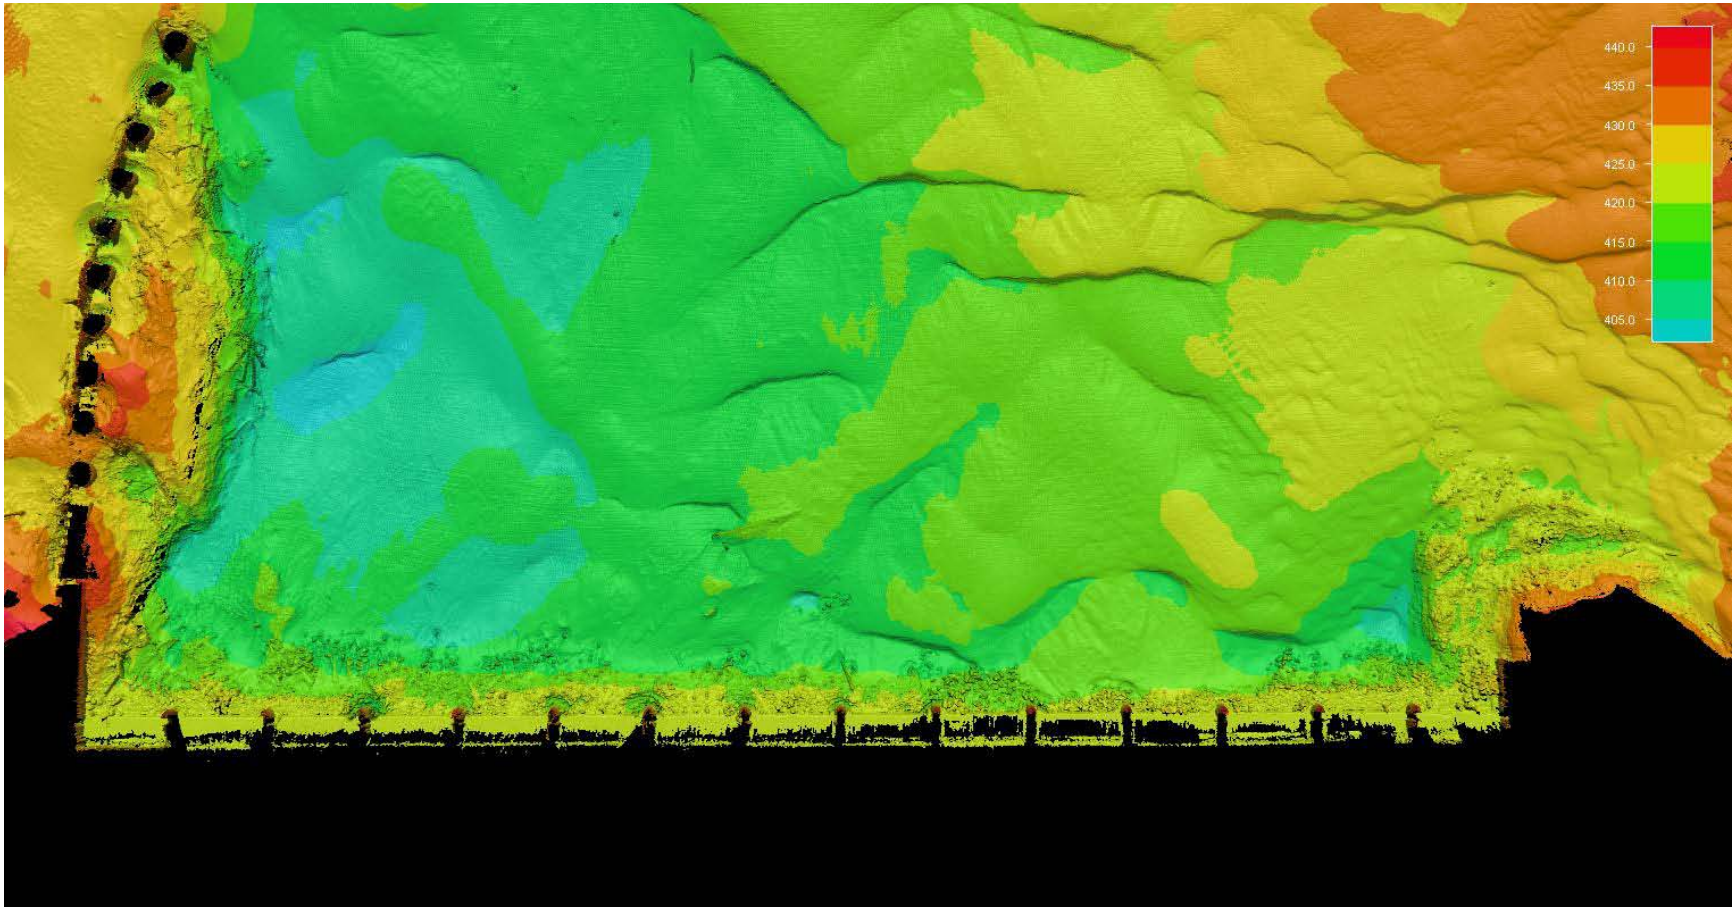
Figure 7 - 2-15-12 Survey

7. February 15, 2012 – Almost no change occurred in the 5 months between surveys; the single aberration is scour up to -6 ft in front of Gate 7 and Pier 8.
