Technical Report M67

**MORO CHUTE HSR MODEL
RIVER MILES 125.00 – 117.00**

HYDRAULIC SEDIMENT RESPONSE MODEL INVESTIGATION

Final Report – March, 2013

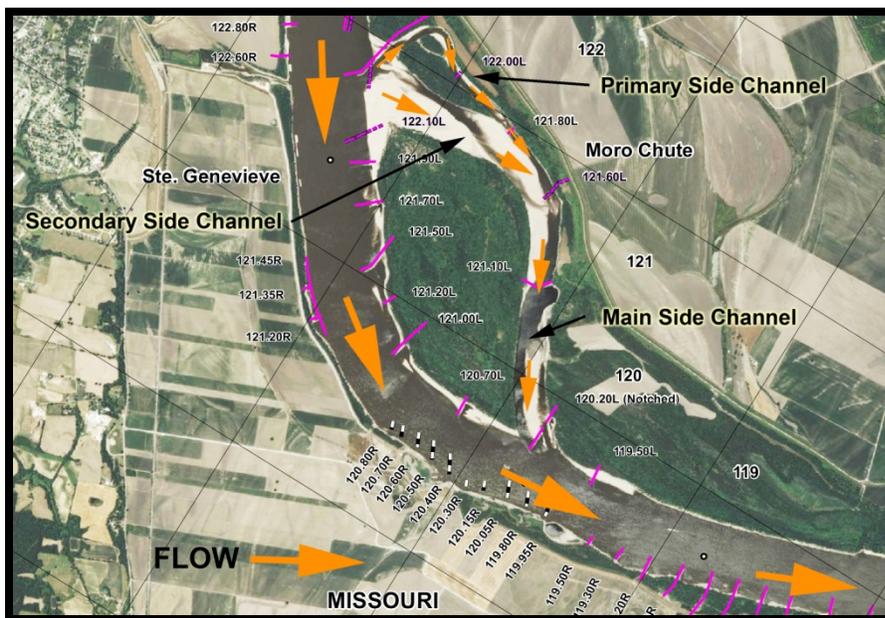
Figure 1: Moro Chute Reach with Flow Trends

At low water there were many structures that prevented flow from passing through Moro Chute. However, if water levels were greater than +15 feet LWRP flow was able to pass through Moro Chute. Approximately 7 months of the year the side channel was dry, leaving exposed sandbars. See Figure 1 for a generalized schematic of the existing flow mechanics in the study reach.

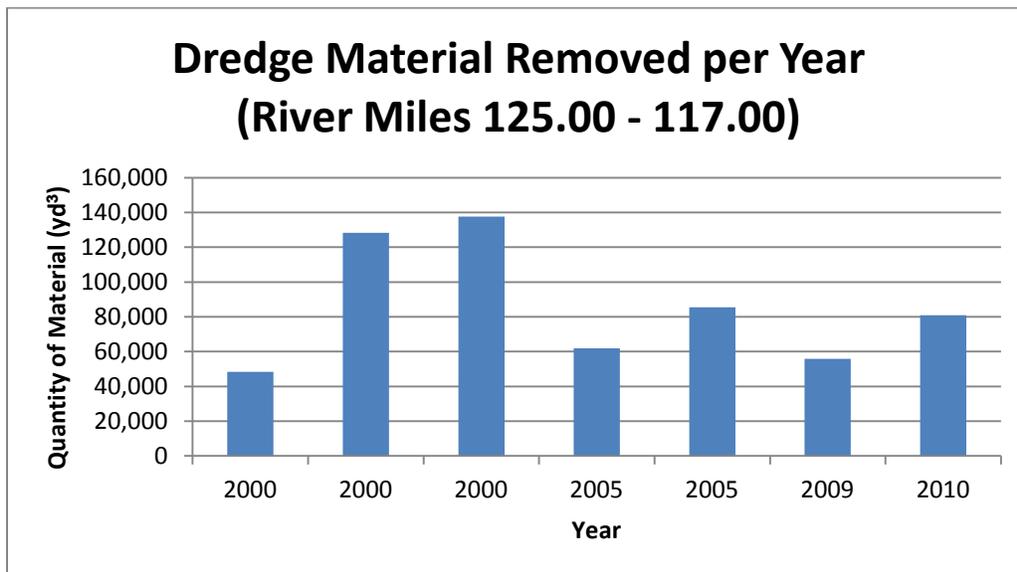
Figure 2: Study Reach Dredge Removal Data

There were many sandbars located along the LDB between the dike fields. Dikes 124.45R, 121.35R, and 121.20R, located along the RDB, were constructed to align the bankline and to protect against erosion. See photograph 1 on Plate 13. To maintain the navigation channel from 2000 to 2010 between RM 123.00 and RM 120.00, approximately 600,000 cubic yards was dredged at a cost of \$1.4 million. Figure 2 shows the dredge material removed per year and Plate 24 displays the dredge areas and dredge disposal locations.
