**CARROLL ISLAND MICRO MODEL STUDY
RIVER MILES 273.0 TO 263.0**

HYDRAULIC MICRO MODEL INVESTIGATION

Technical Report M37

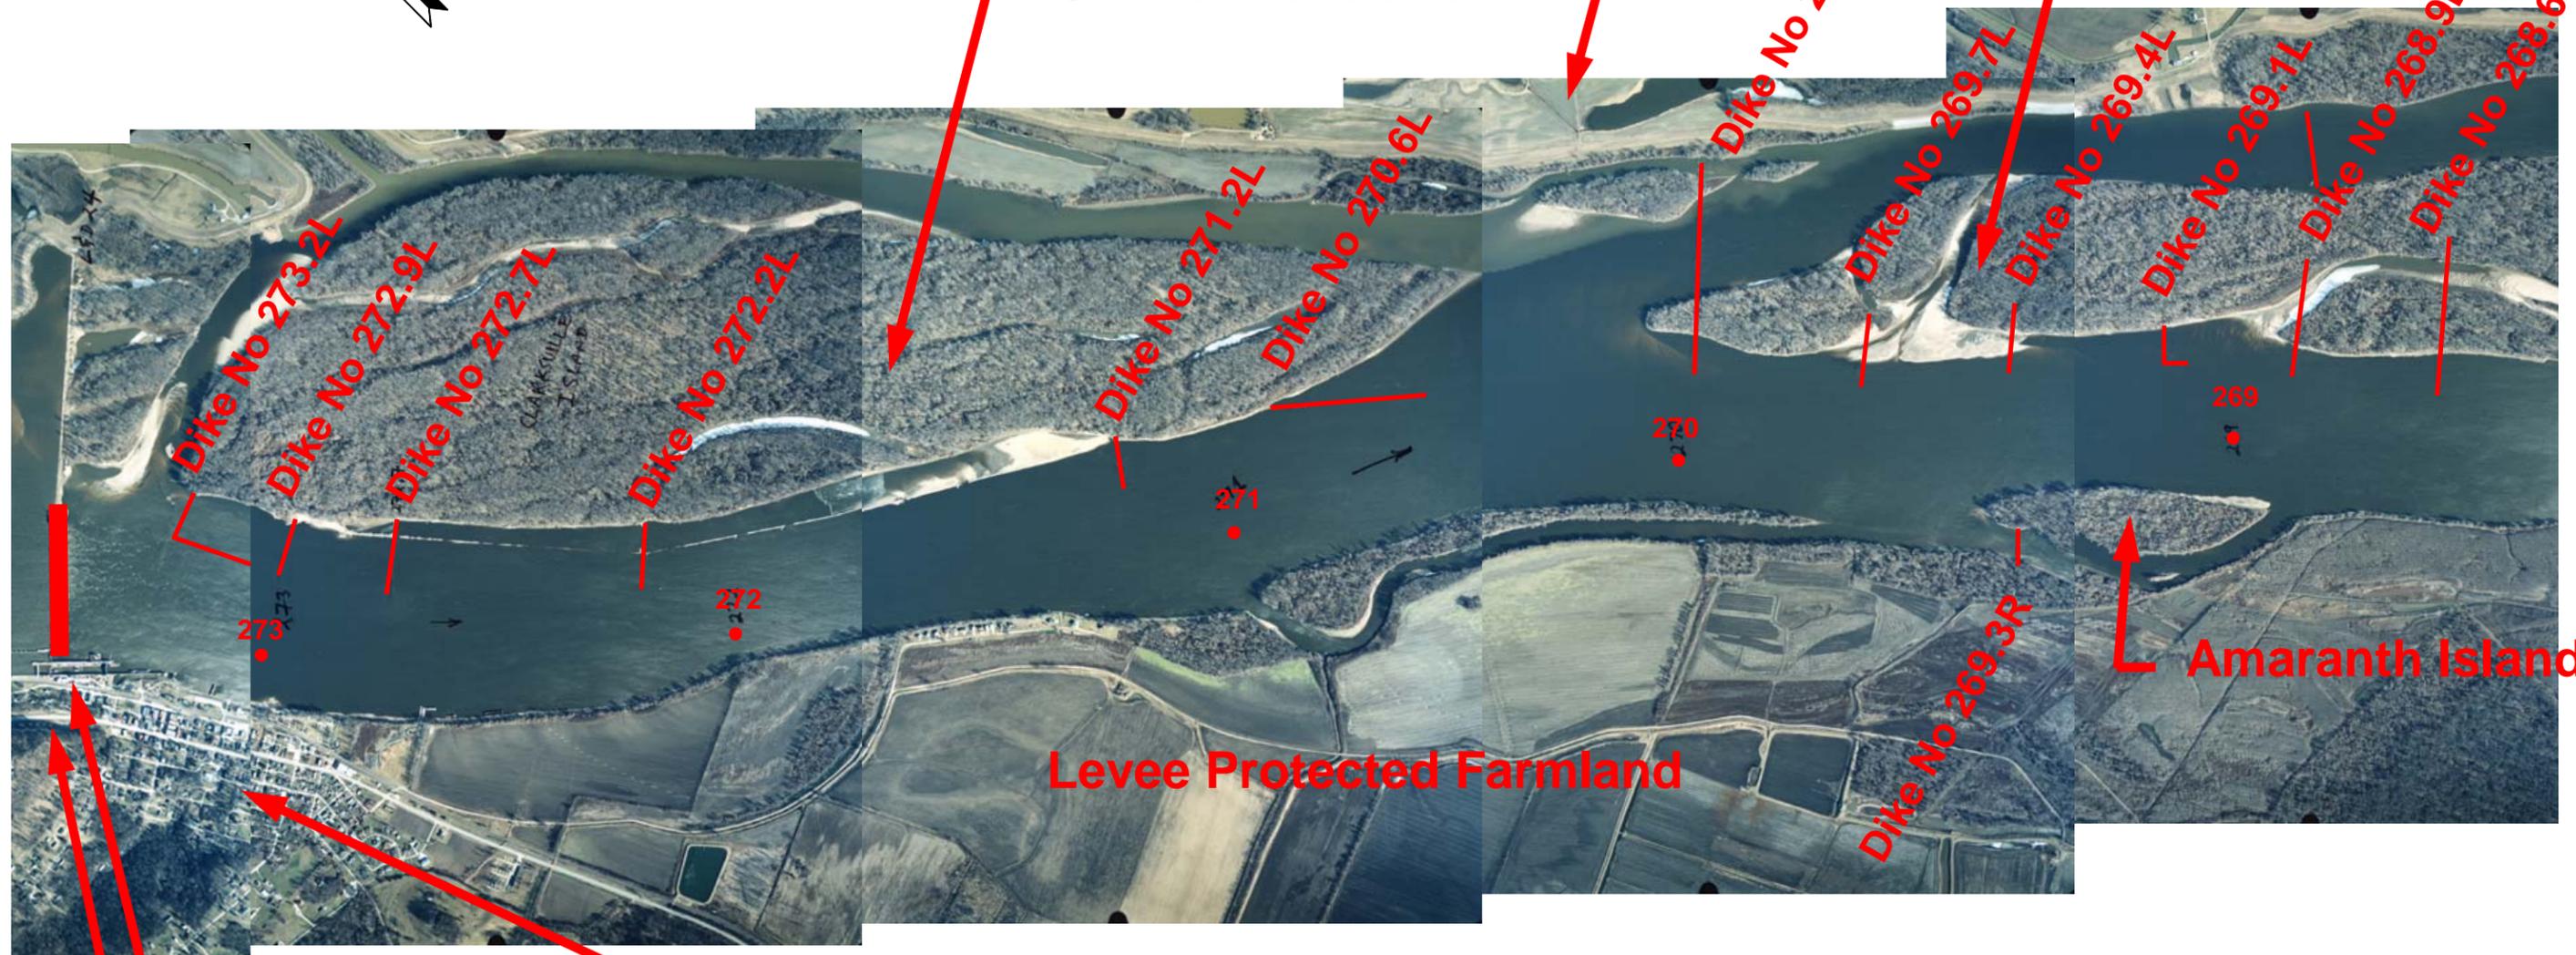
Plates 2 and 3 together are a 2003 aerial photograph illustrating the geomorphology and nomenclature of the Upper Mississippi River between Miles 273.0 and 263.0. This reach of river contains several islands and side channels, although it is not considered a braided channel. A controlling factor for this reach of river is the Clarksville Lock and Dam (Plate 4) at Mile 273.3. The dam consists of gates in the main channel, and an overflow spillway connecting the Illinois bank to the concrete dam structure. The 600 ft lock is along the Missouri bank. Also on the Missouri side, the right descending bank (RDB) consists of 300 to 400 ft high bluffs on the upstream end near the dam, with flat, levee-protected farmland on the downstream end. On the Illinois side, the entire reach consists of flat, levee-protected farmland (Plate 5).

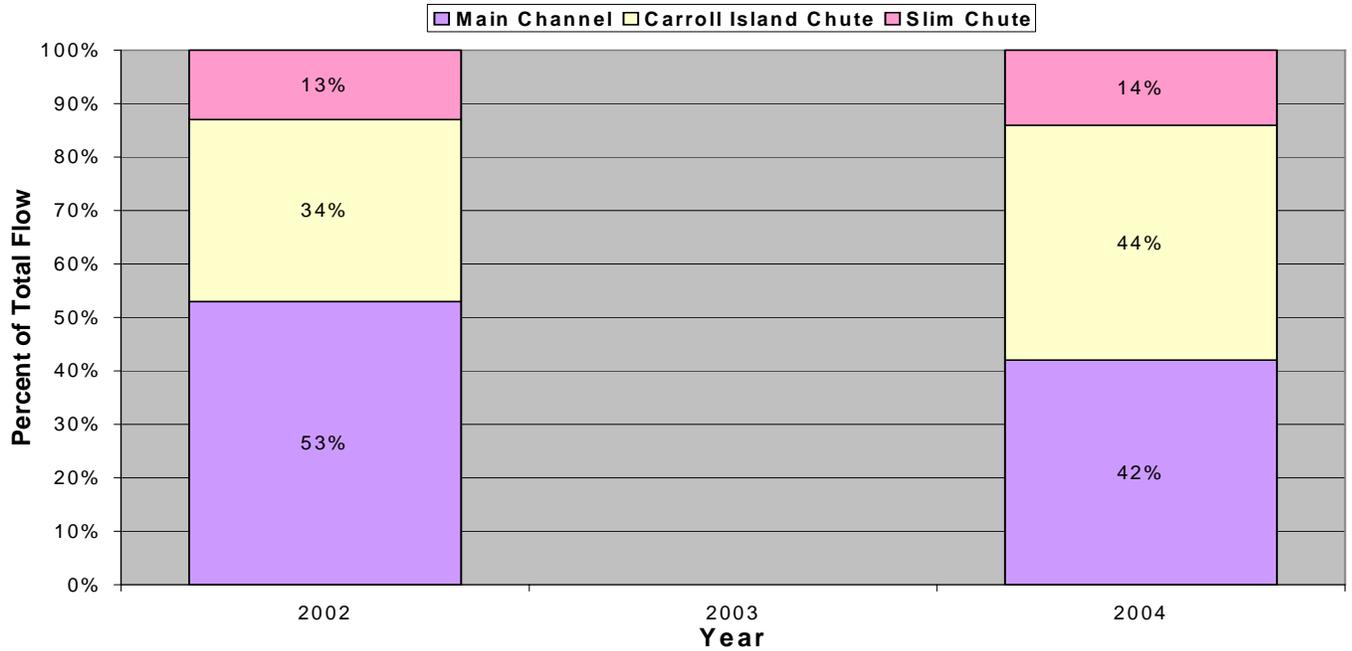
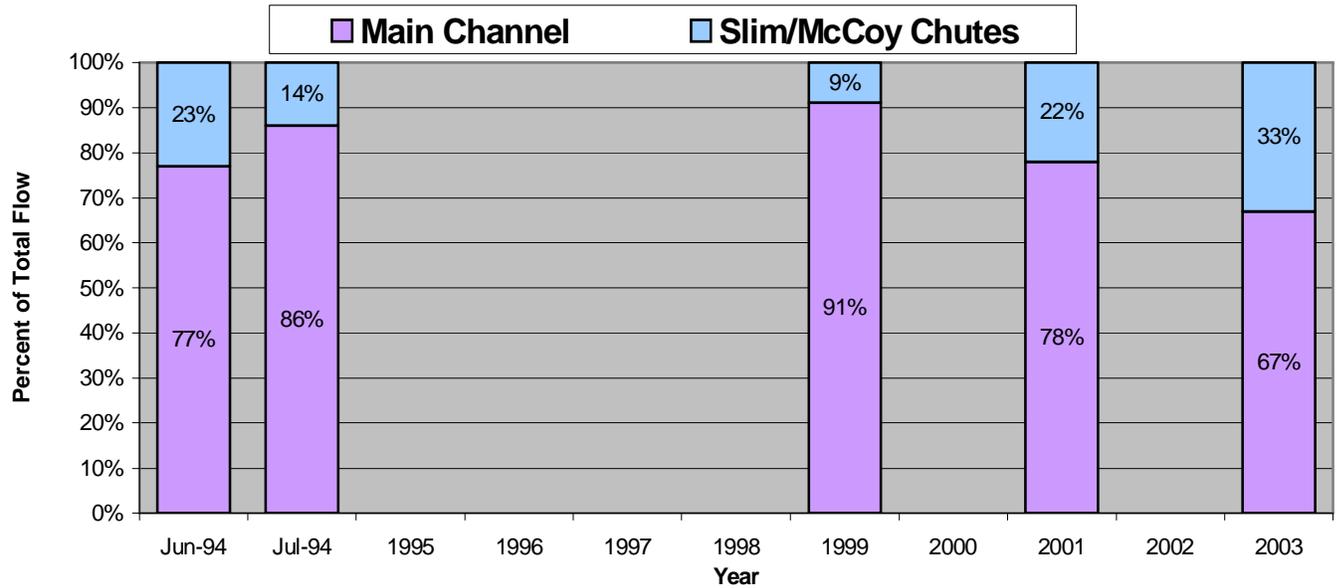
Flow Splits at River Mile 266.5

Recent discharge measurements have revealed a relatively steady percentage of the total flow, between 35 and 40 percent, is within the Carroll Island Chute. Plate 8 displays flow split measurements collected at Miles 266.5 and 264.0 between 1994 and 2004. Each colored bar shows the percentage of total discharge handled by each channel throughout the years. It is reasonable to assume that, with 50 percent or less of the total flow not passing through the approximately 1750 foot wide main channel, there is insufficient energy remaining to maintain the required 9 foot navigation channel adjacent to Carroll Island and Coon Island.

Carroll Island Chute draws a significant amount of flow from the main channel (indicated in the Flow Distribution Data (Plate 8)), thus reducing the energy in the main channel. This lower energy condition causes shallower depths in the main channel and thus the need for frequent dredging. Plate 9 shows the areas of significant dredging and typical disposal sites. The most significant dredging areas are in the main channel adjacent to the upstream end of Carroll Island and adjacent to Coon Island. Dredging has been costlier and required at less frequent intervals adjacent to the middle and downstream end of Carroll Island.

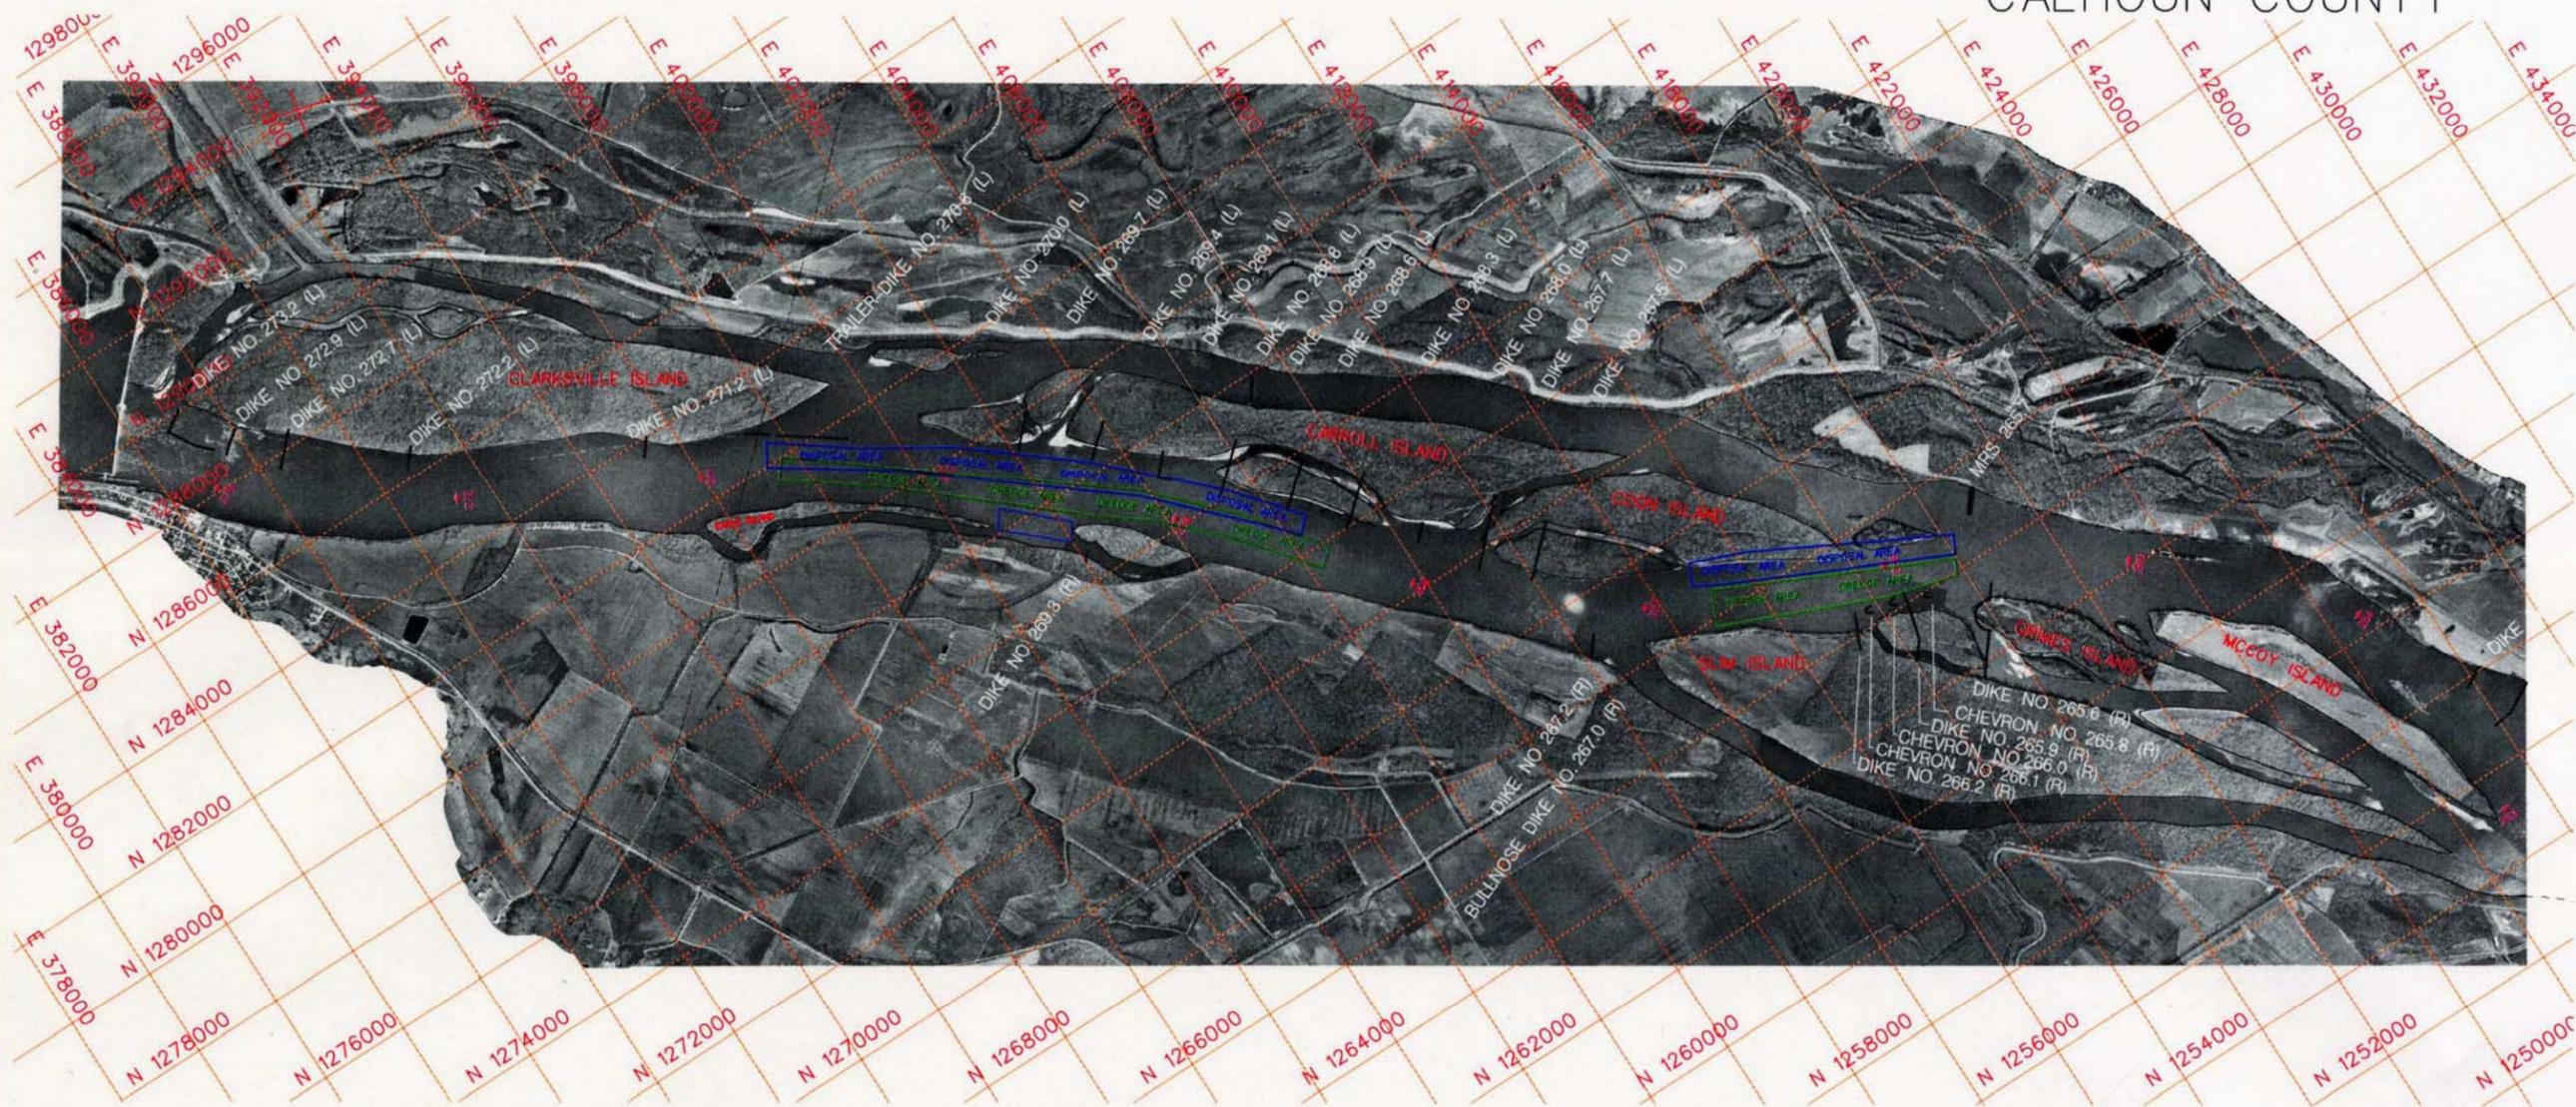
PREPARED BY: J. BROWN DRAWN BY: E. RIFF CHECKED BY: R. DAVINROY	DESIGN FILE: CAROLDREDGE.DGN PLOT SCALE: 4000	PLATE NO. 9 PLOT DATE: 09/22

This reach of the Mississippi River has been very troublesome. Dredging has occurred on an almost yearly basis in two locations. Plate 9 shows the dredge cut locations and disposal sites between Miles 270.8 to 268.2 and Miles 267.7 to 265.5 for the dredging that occurred between 1979 and 2004. Plate 10 shows a graph of the yearly dredging totals from 1979 to 2004 between Miles 227.6 and 265.8. Within this eight-mile reach, approximately 4.8 million cubic yards of material was dredged at a cost of nearly \$6.8 million over a period of 26 years. That translated into a yearly average of over 185,000 cubic yards of material at a cost of nearly \$262,000 per year. The area between Miles 270.8 and 268.2, just upstream and adjacent to the upper portion of Carroll Island, was dredged in 12 of the 26 years and accounted for 54% of the total volume and 49% of the total costs. The area adjacent and downstream of the lower portion of Carroll Island between Miles 267.7 and 265.5 was dredged in 17 of the 26 years and accounted for 46% of the total volume and 51% of the total cost. Data before 1978 was not analyzed because dredging records were not accurately kept before this time.

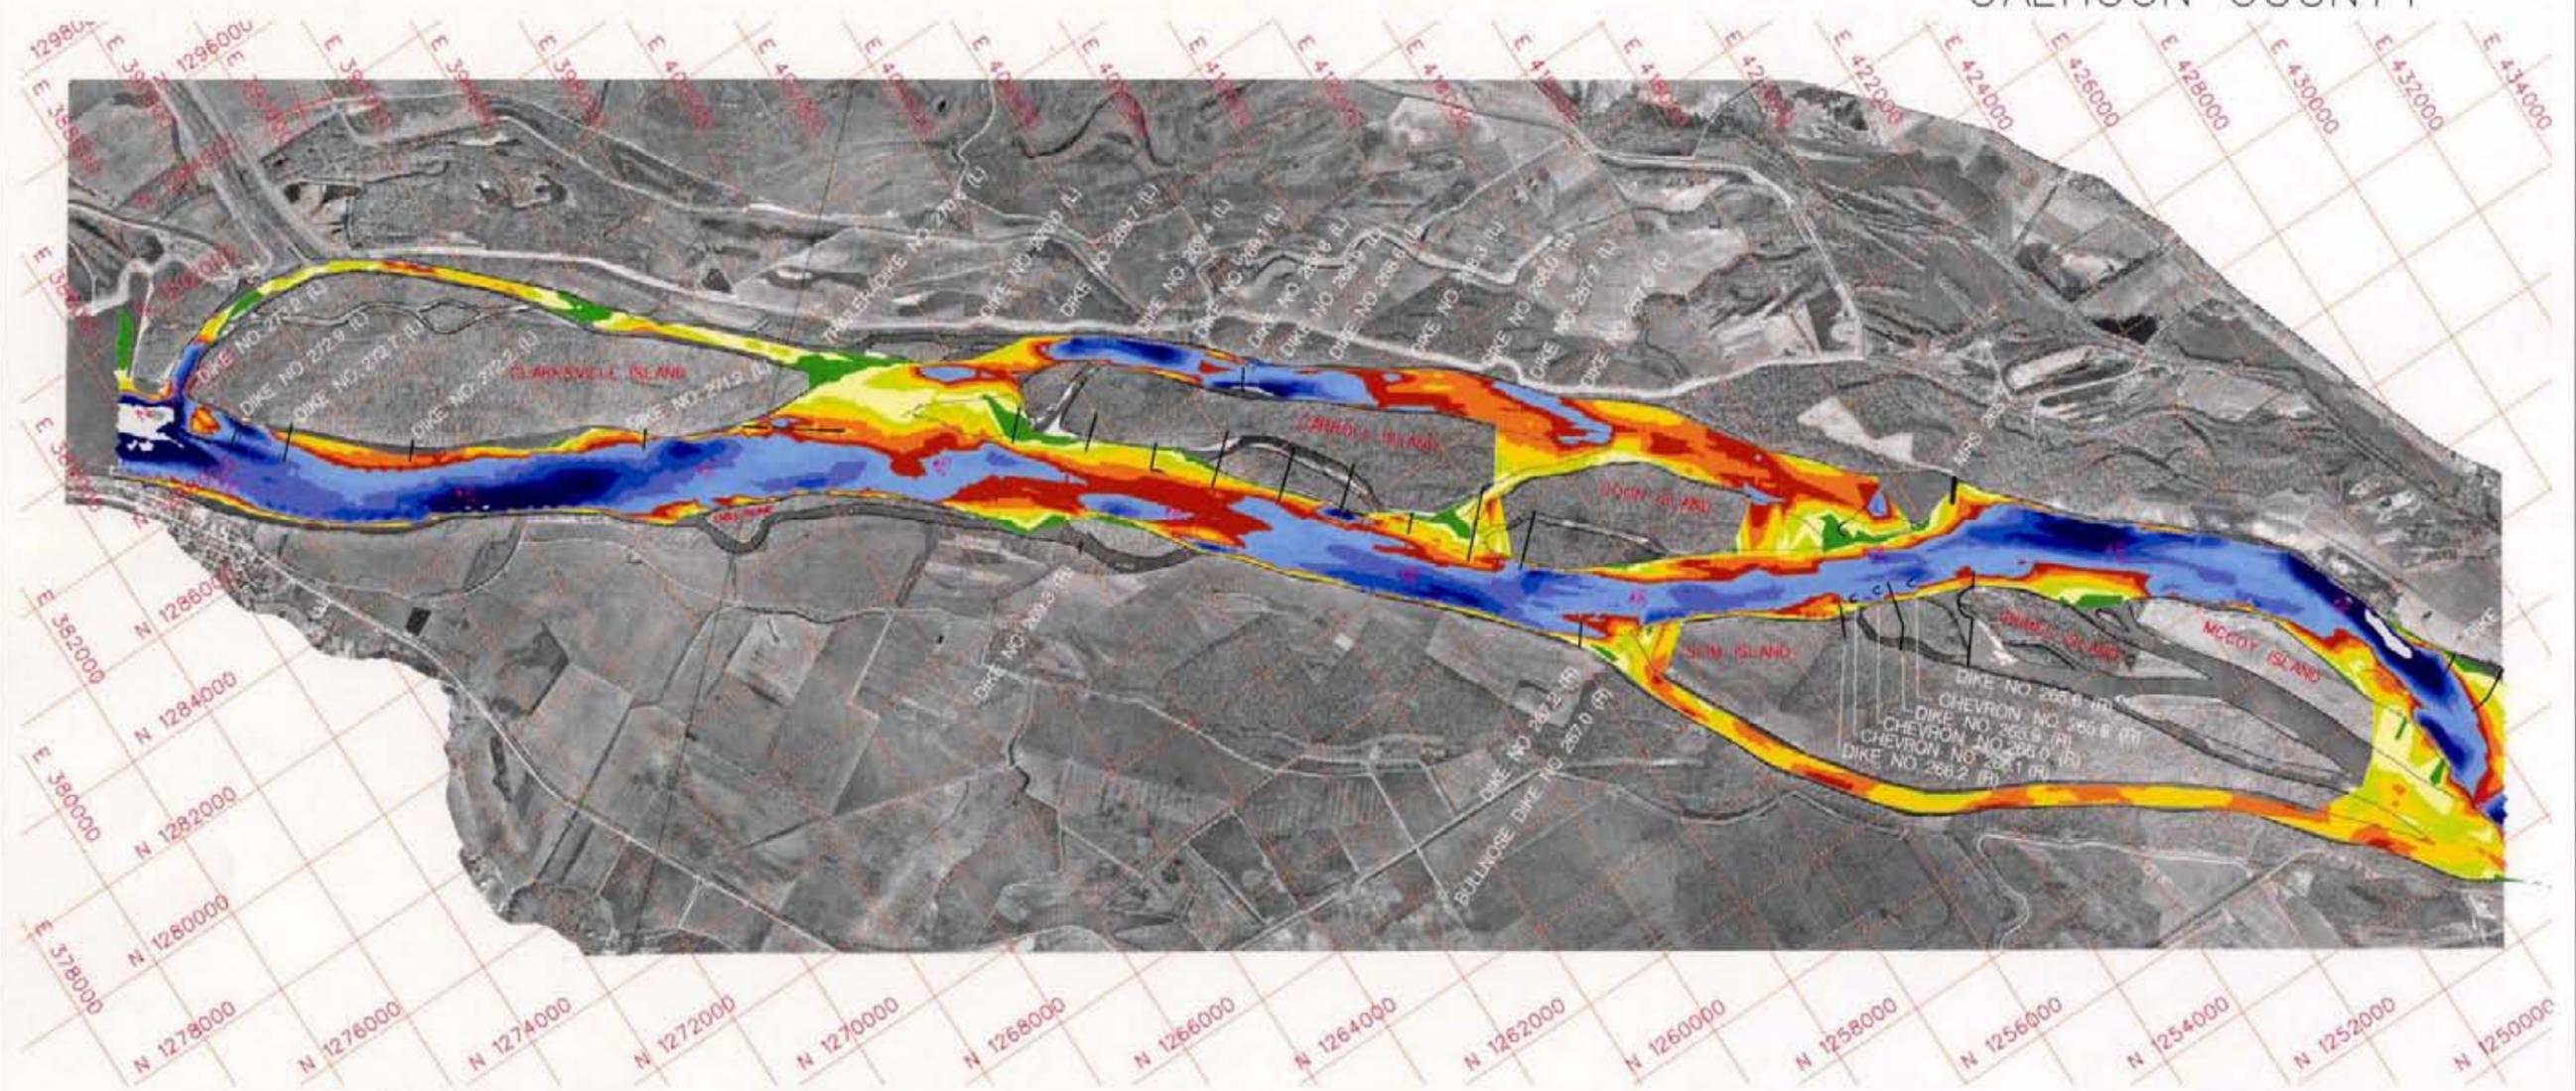
<p>DESIGN FILE: 93SURVEY.DGN PLOT SCALE: 3/625</p>	<p>PLATE NO. 18</p>

Plate 18 shows the planform and bathymetry of the Carroll Island reach in 1993. No significant differences existed between the 1993 bathymetry and island layout and the 1986 bathymetry and island layout. However, a portion of the repetitive dredging location is evident between Mile 270.2 and Mile 268.5.

To determine the general bathymetric characteristics and sediment response trends that existed in the prototype, several present and historic hydrographic surveys were examined. Plates 18 through 21 are plan view hydrographic survey maps of the Mississippi River from 1993, 1995, 1997, and 1999, respectively.

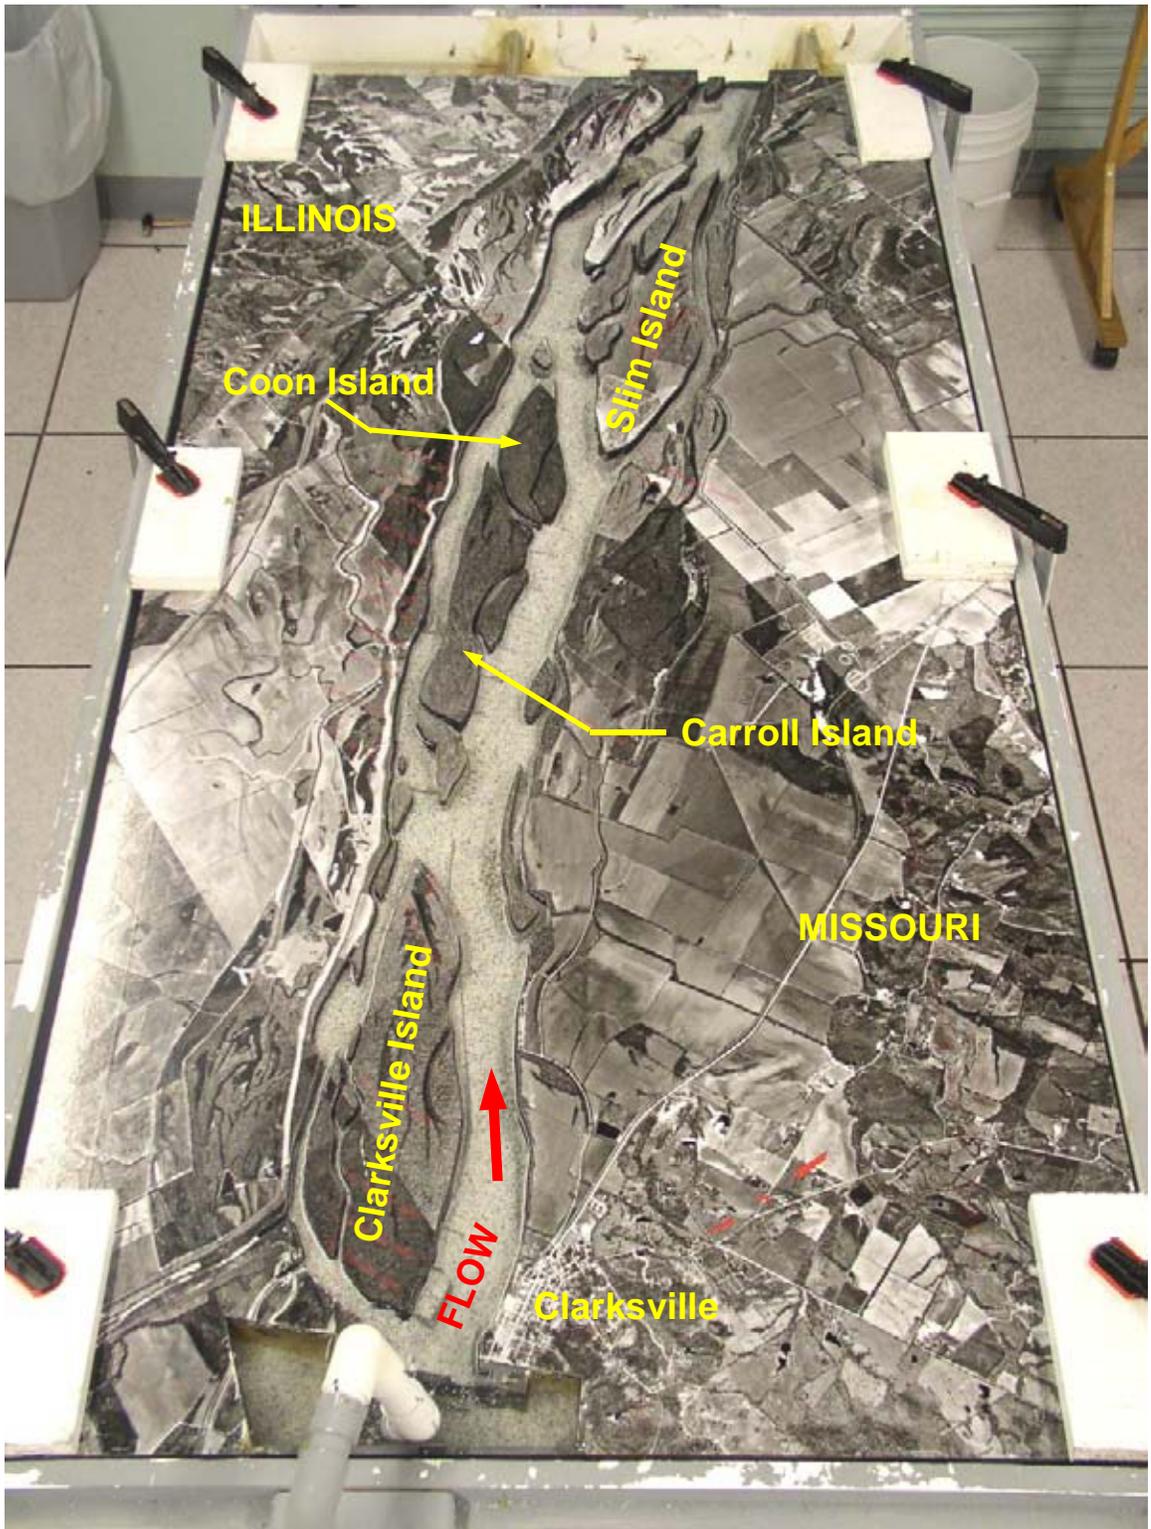
In order to investigate the sediment transport conditions described previously, a physical hydraulic micro model was designed and constructed. Plate 22 is a photograph of the hydraulic micro model used in this study. The zero reference plane of the prototype was assumed to be the MP (Minimum Pool) condition. The model employed a horizontal scale of 1 inch = 800 feet, or 1:9600, and a vertical scale of 1 inch = 27 feet, or 1:324, for a 30 to 1 distortion ratio of linear scales. This distortion supplied the necessary forces required for the simulation of sediment transport conditions similar to those of the prototype. The bed material was granular plastic urea, Type II, with a specific gravity of 1.40.

The micro model insert was constructed according to the 1995 high-resolution aerial photography of the study reach shown as a background on Plates 18-21, and Plates 23-42. The insert was then mounted in a standard micro model hydraulic flume. The riverbanks of the model were constructed from dense polystyrene foam, and modified during calibration with galvanized steel mesh. Rotational jacks located within the hydraulic flume controlled the slope of the model. The measured slope of the insert and flume was approximately 0.00625 inch/inch. River training structures in the model were made of galvanized steel mesh.

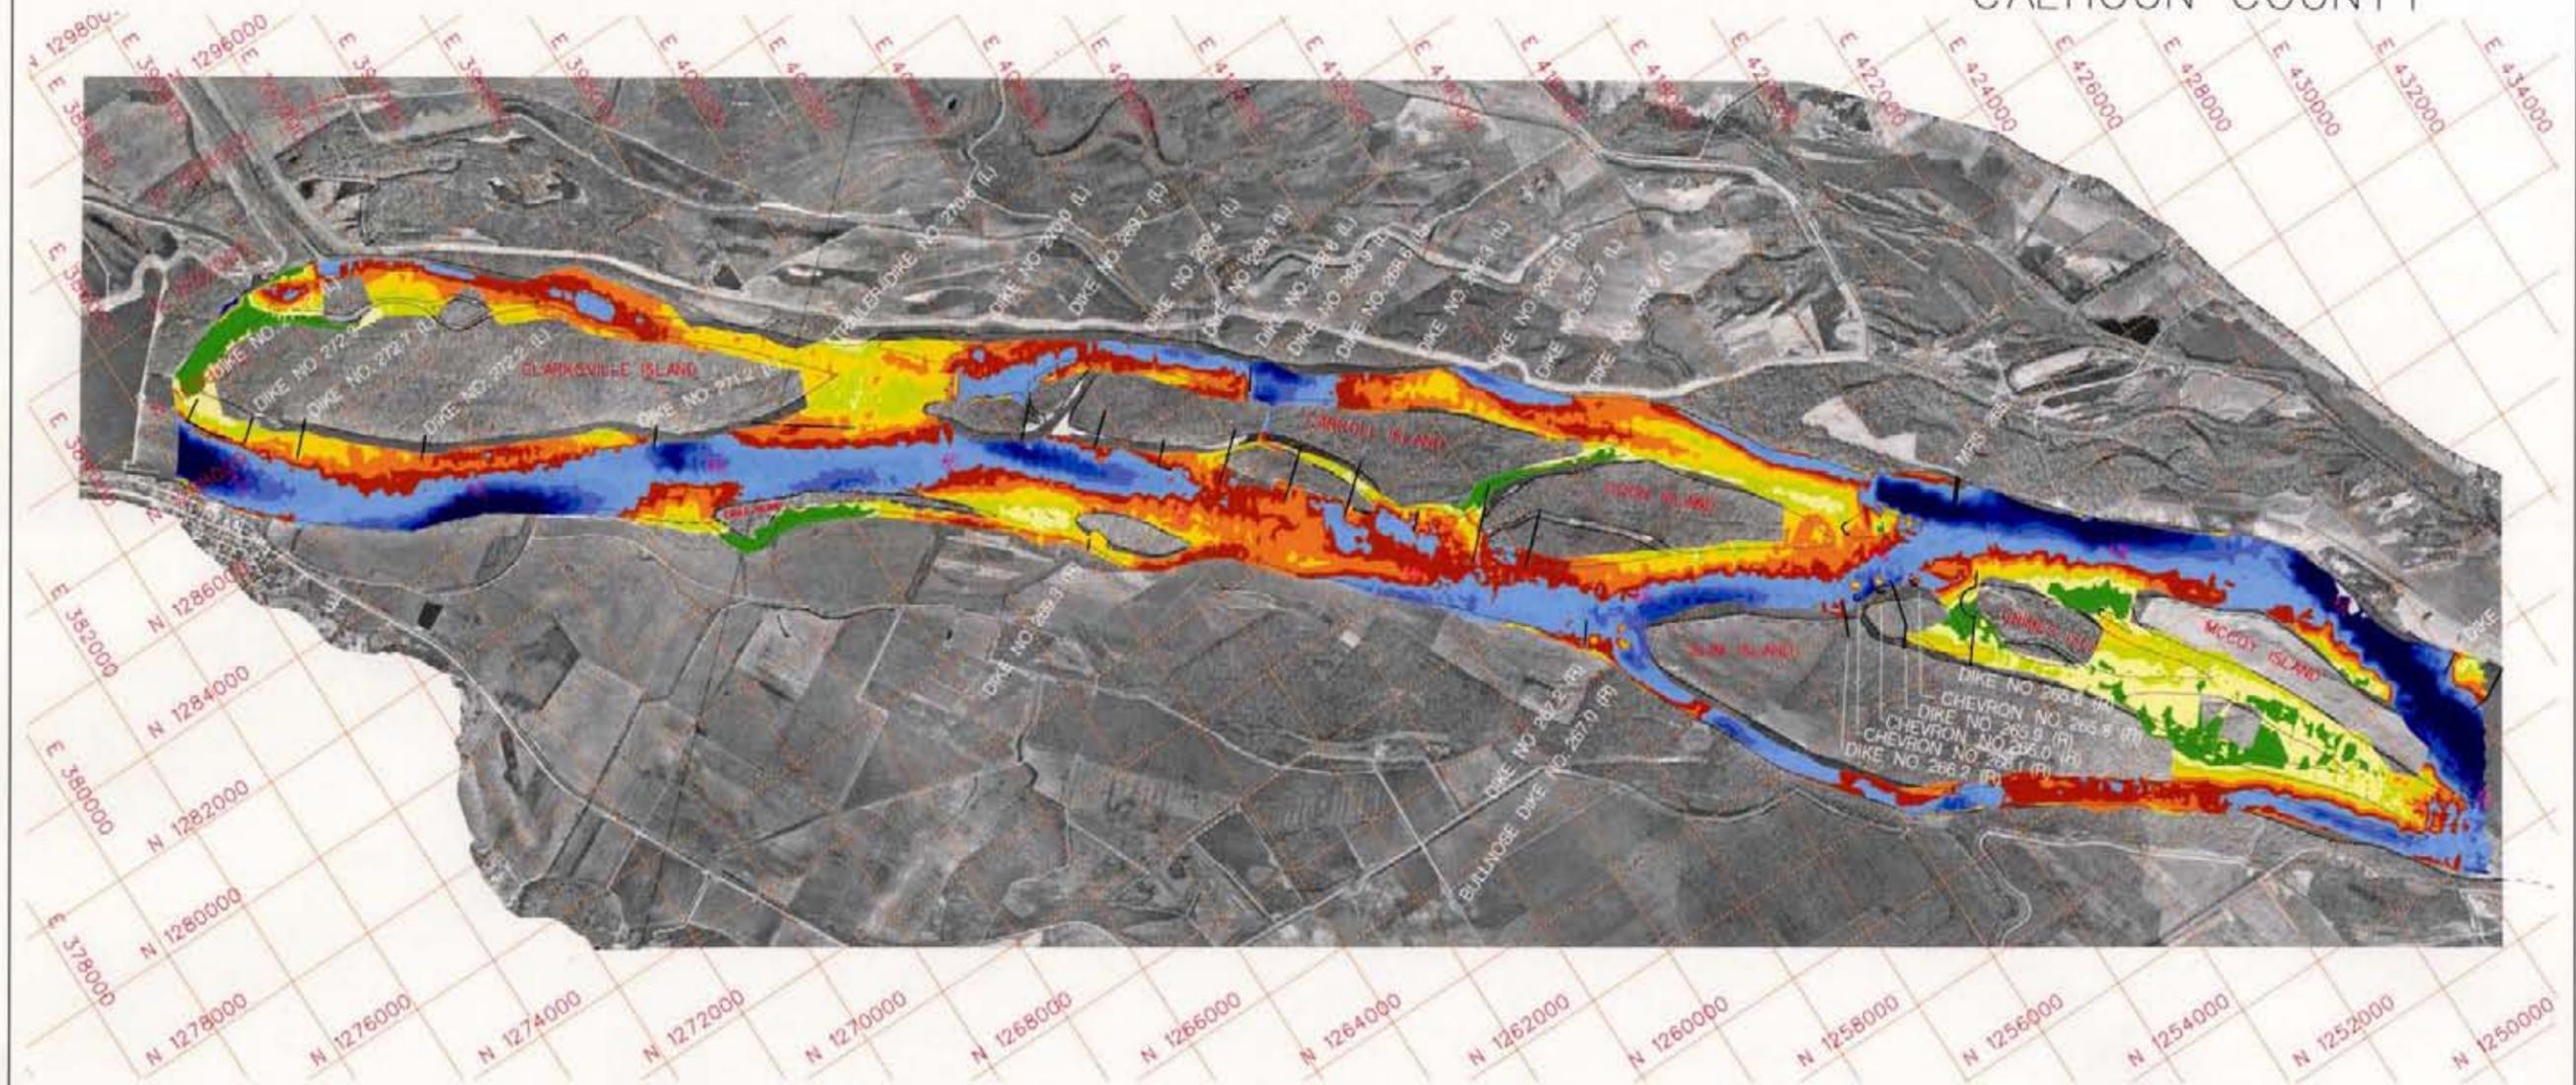
DESIGN FILE: BASE.DGN PLOT SCALE: 4000	PLATE NO: 23

Results of the micro model base test bathymetry and a comparison to the 1993 through 1999 prototype surveys indicated the following trends:

Overall, the trends of the model as observed in the base test were similar to those observed from the prototype surveys, especially in the reaches of river just upstream and just downstream of the repetitive dredging areas adjacent to Carroll Island.

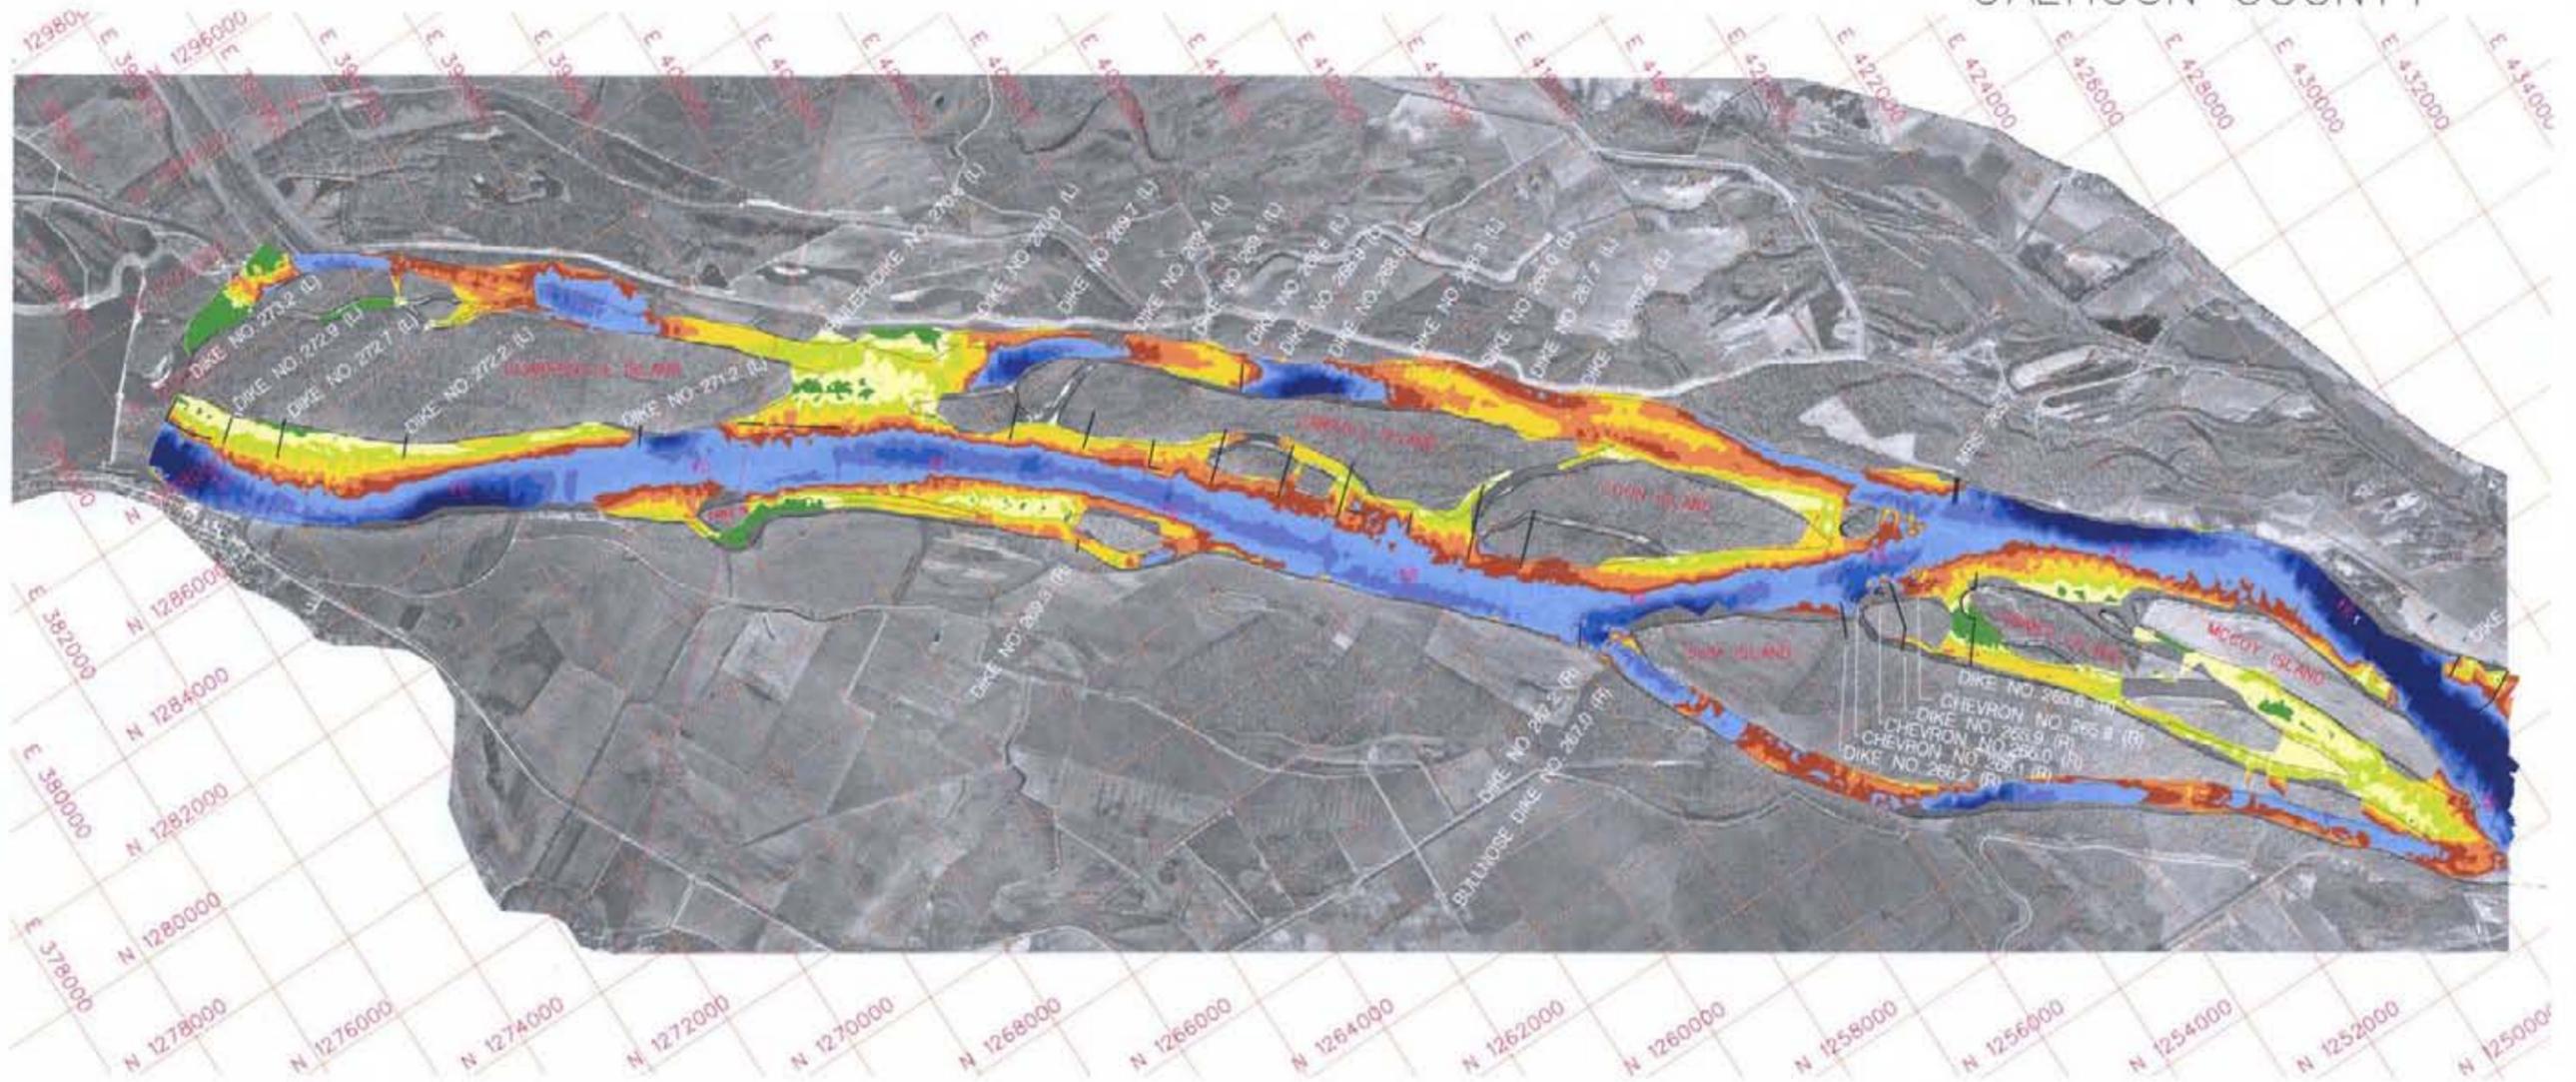
DESIGN FILE: DREGESIM.DGN	PLATE NO. 24
PLOT SCALE: 4000	PLOT DATE:

prototype bathymetry's ultimate bed response with no dredging. Shallow water, - 8 ft MP and shallower, is prevalent from Mile 269.0 and downstream for approximately 1.0 miles. Plate 24 shows the simulated dredging condition in the model. The thalweg was placed artificially near the center of the channel in both dredging locations similar to the artificial thalweg placement in the prototype.

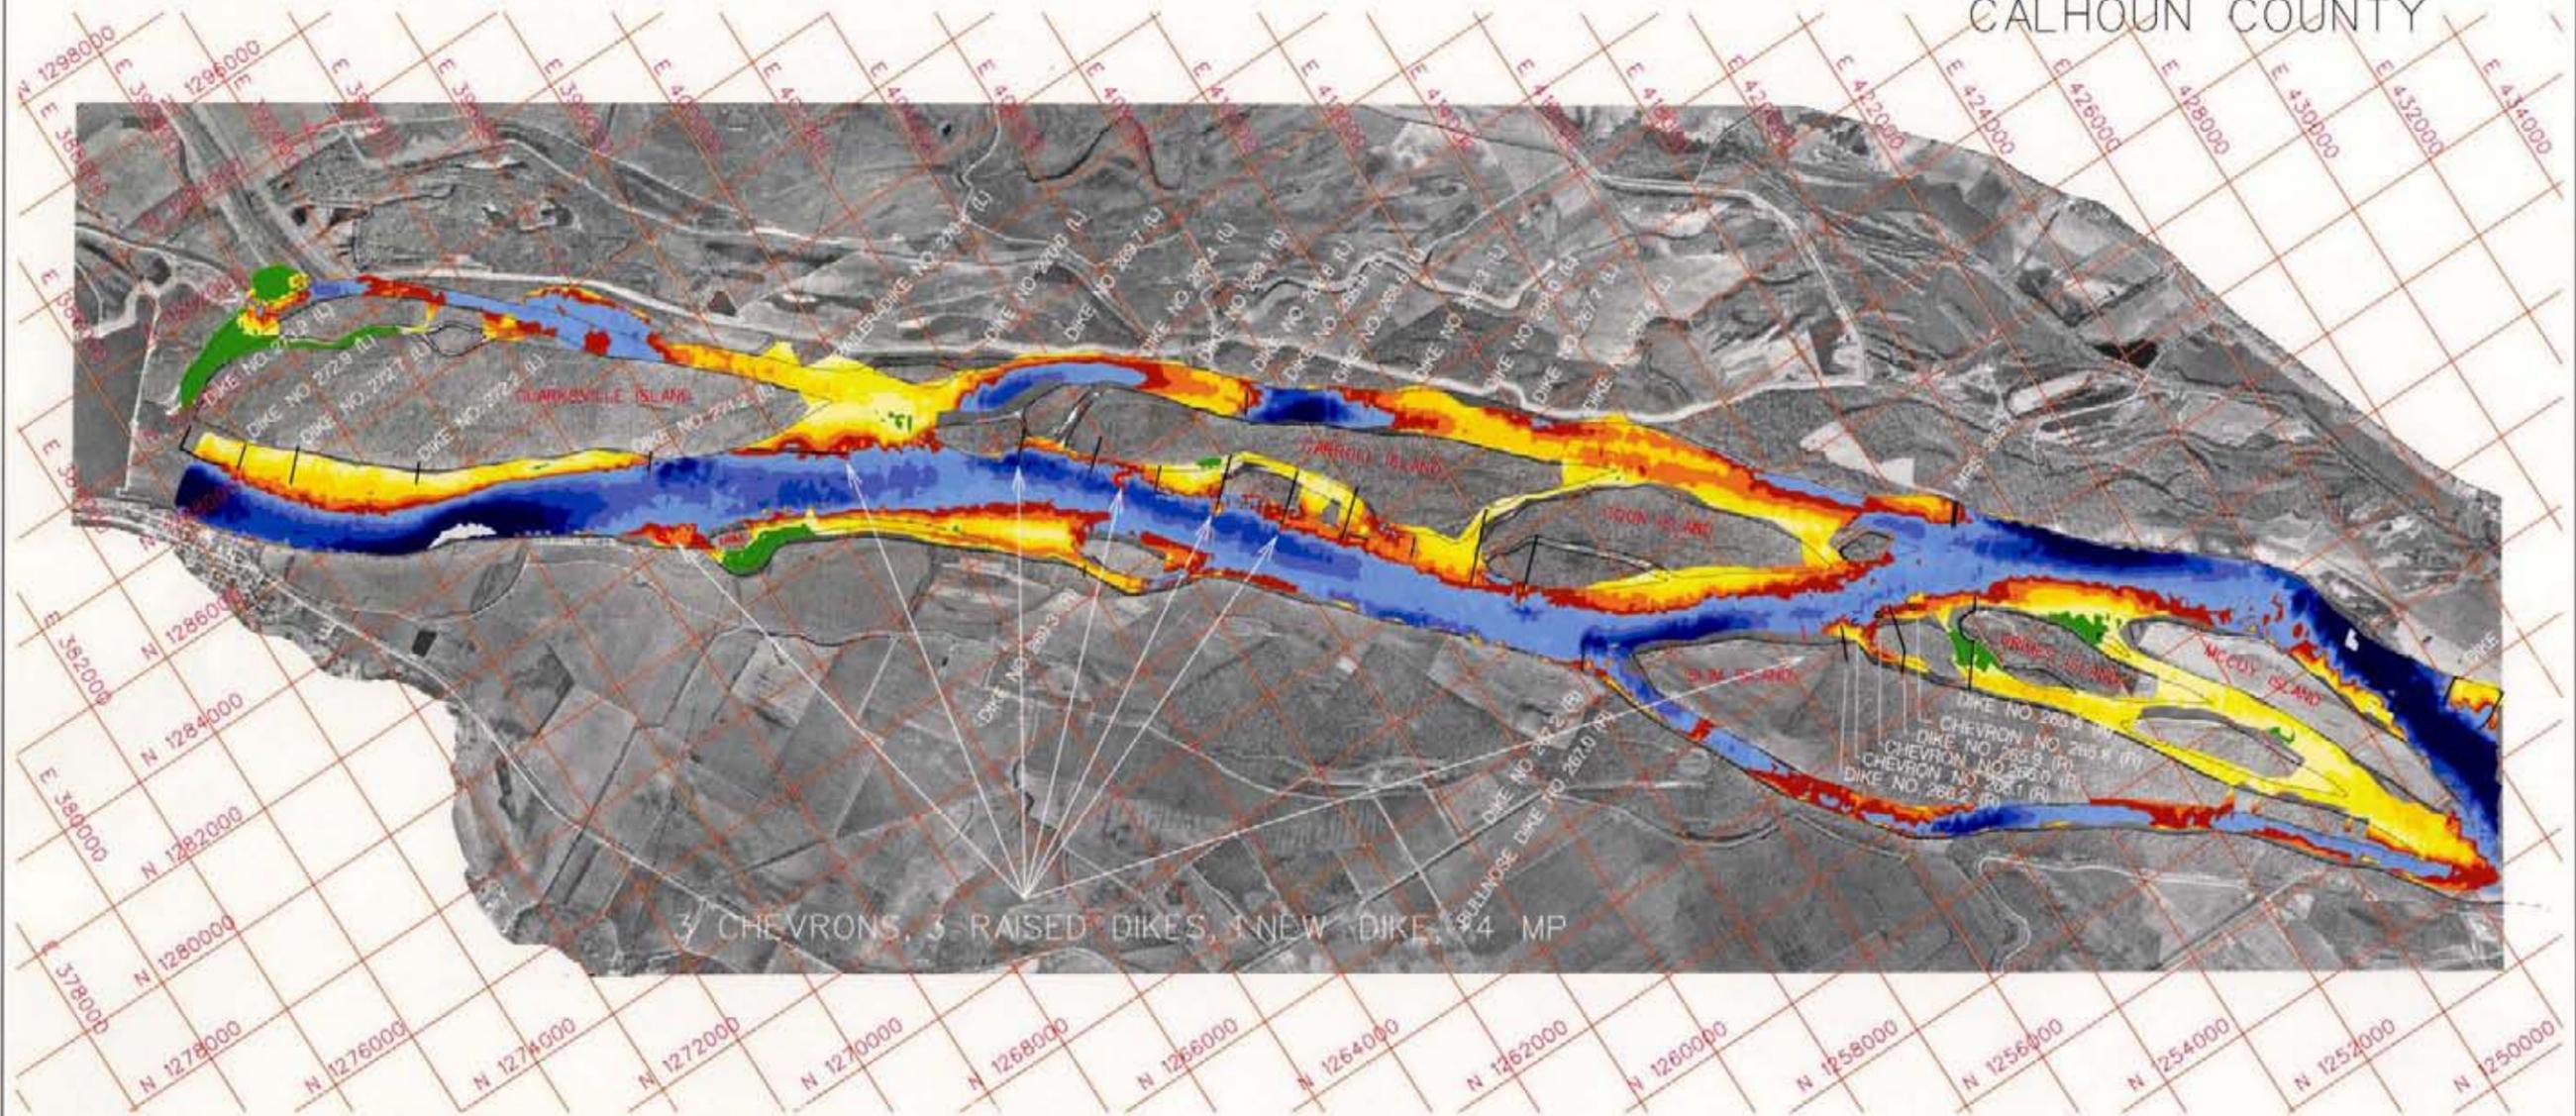
DESIGN FILE: ALTR16.DGN PLOT SCALE: 4000	PLOT DATE: PLATE NO. 40

Alternative 16 (Plate 40) is the recommended plan to solve the dredging problems of the Carroll Island Reach. In Alternative 16, 3 chevrons, 3 raised dikes, and 1 new dike are utilized. The structures are configured as follows:

It is recommended that in implementing these structures into the Carroll Island Reach, a phased construction approach should be followed. This is especially true for the new Dike to be constructed at Mile 266.3. Important biological habitat exists in the chevron structures just downstream of this dike, thus a phased construction is recommended. A phased construction will allow for getting the maximum benefit from the structure without unnecessarily impacting this habitat. In addition, a close monitoring program of navigation channel conditions both before and after construction should be incorporated.
