MELVIN PRICE LOCKS AND DAM

PROGRESS REPORT 2004 - 2006

DESIGN MEMORANDUM NO. 24
AVOID AND MINIMIZE MEASURES

DESIGN MEMORANDUM NO. 24
AVOID AND MINIMIZE MEASURES
2004 - 2006 PROGRESS REPORT

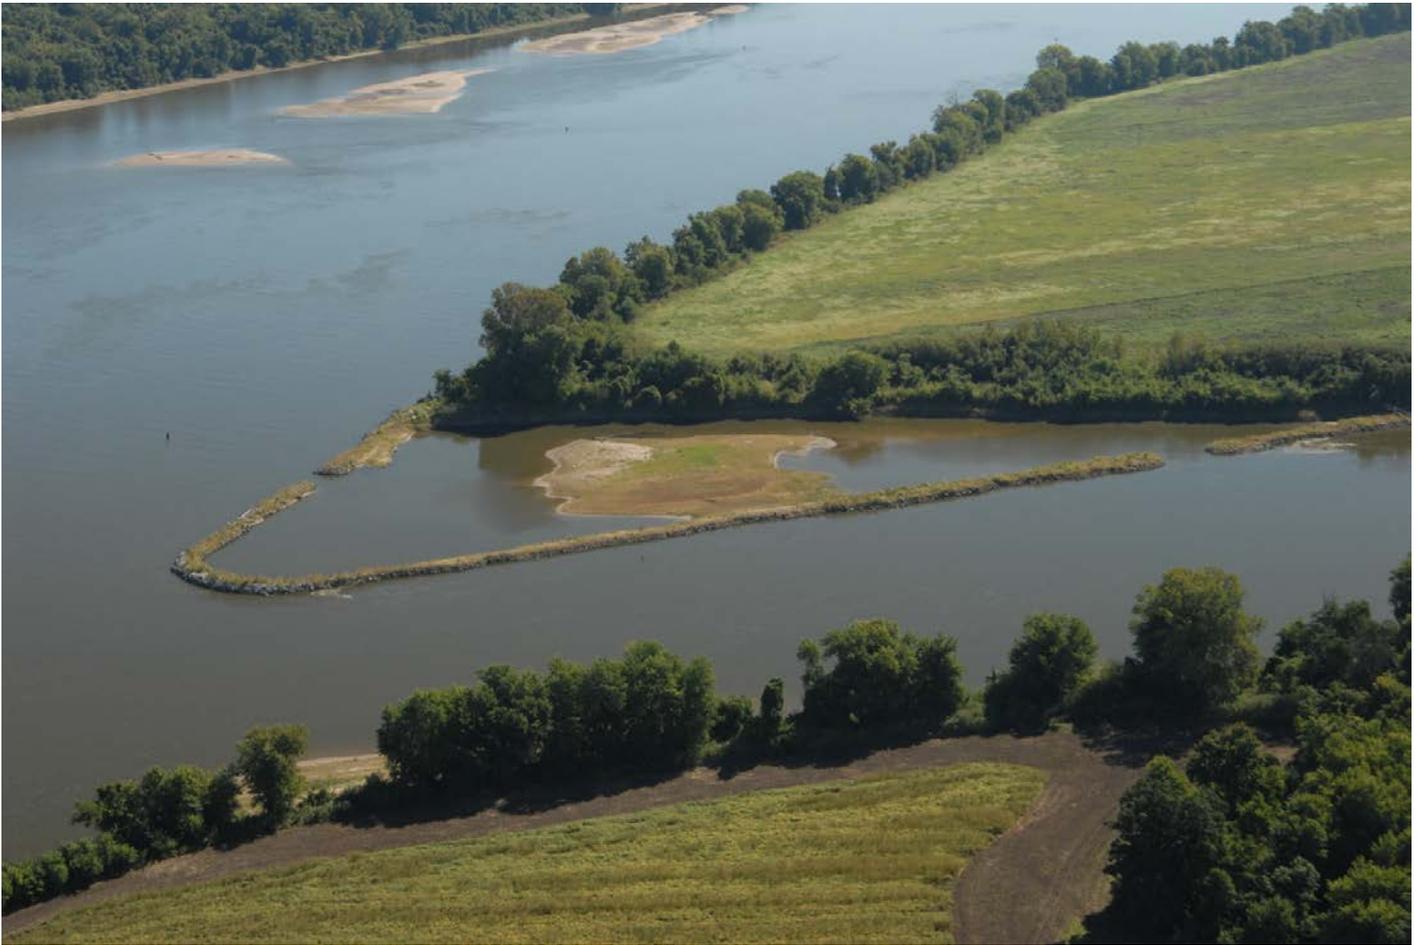
Cover photo

Slim Island Bullnose at RM 267.0R. A bullnose was constructed at the tip of Slim Island in 1996 in order to curb severe erosion that had occurred at the upstream tip of the island after the flood of 1993. State and Federal natural resource agencies partners in the Avoid and Minimize program have long requested that the Corps of Engineers consider ways to incorporate environmental benefits from the structures we build in our dike and revetment program. Electro-fishing was conducted in 2003 and 2004 to evaluate the structures usefulness as fish habitat. Results show that this structure provides habitat similar to chevrons constructed previously in other parts of the river. Post construction monitoring is a critical tool in assessing the value and impact of these structures as both river training structures and as aquatic habitat.

A bullnose was constructed at the tip of Slim Island in 1996 in order to curb severe erosion that had occurred at the upstream tip of the island after the flood of 1993. Electro-fishing was conducted in 2003 and 2004 to evaluate the structures usefulness as fish habitat. Results show that this structure provides habitat similar to chevrons constructed previously in other parts of the river. Collections in the two sample years consisted of 166 fish and 22 species.

Pool 25, River Mile 267 Biological Monitoring. The bullnose at Slim Island was sampled by St. Louis District staff with electrofishing in both 2003 and 2004. Notches were positioned on the bullnose to allow fish movement in and out of the protected area. The samples from both years shared similar characteristics with species such as shortnose gar, gizzard shad, freshwater drum and bluegill favoring the inside of the bullnose, and species like catfish, largemouth bass, smallmouth bass, and carp being found outside of the bullnose. In all, 21 species were collected over the two years.

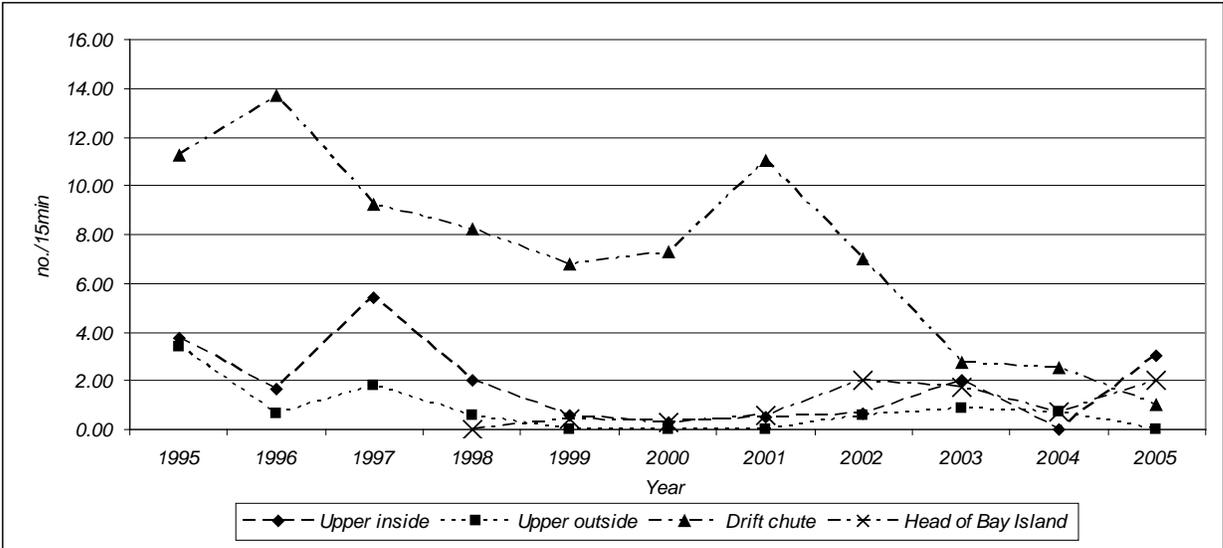
Figure 3. Annual catch rates of smallmouth buffalo at four chevron dike study sites.

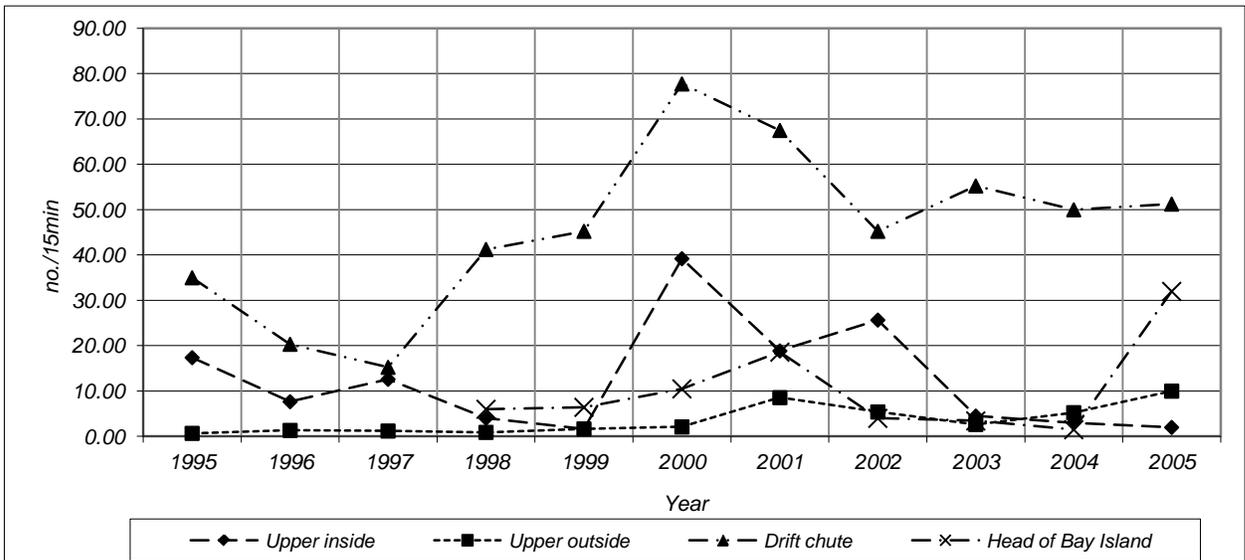
Figure 4. Annual catch rates of bluegill at four chevron dike study sites.

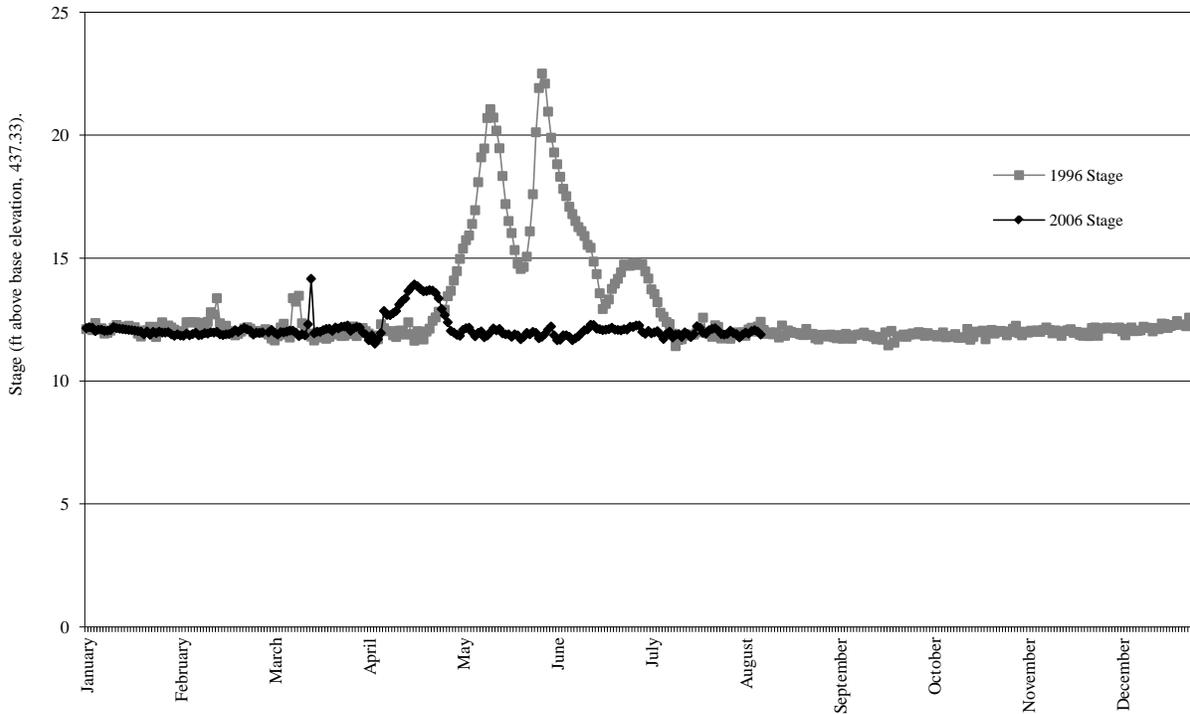
Figure 1. The 1996 and 2006 river stages* at river mile 282.9 near Louisiana, Missouri.

*Data from USACE 2006. At the time of this report, preliminary data for 2006 were only available to 10 August 2006.

There are two main factors that could explain the vegetation differences observed in 2006 compared to 1996. The high water stages in May through July of 1996 resulted in submergence of large portions of the three chevron islands. At the time of the survey, the majority of the islands had been above water for less than 50 days (Fig. 1). This submergence would prevent extensive vegetation growth like that observed in 2006. Conversely, the stage level had been low for the majority of 2006 allowing for extensive vegetation (Fig. 1). The second contributing factor is island age. The islands had been established for only three years during the 1996 survey. The substrate was predominantly loose sand which is not conducive to vegetation. The dense vegetation observed in the upper two thirds of the islands during the 2006 survey required time and sufficient suitable substrate, and the vegetations' presence may be a sign of continued succession and silt build up.
